CM² RESIDENTIAL INSPECTION

5245 Mica Ct
Redding, CA 96003

CM² Residential Signature Inspection Report

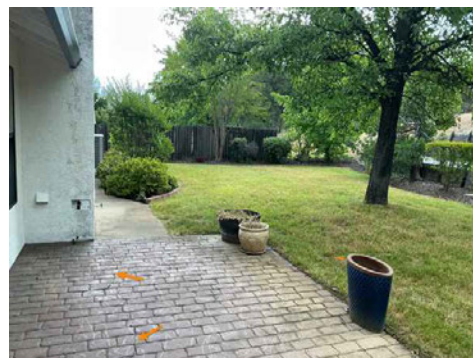
FLATWORK CRACKING / SETTLEMENT

Cracking, displacement, and/or differential movement was observed at portions of the exterior flatwork.

Movement and surface deterioration may create trip hazards, drainage concerns, accelerated wear, or continued settlement over time depending on severity and progression.

Monitor for continued movement and repair or replacement by a qualified contractor may be warranted where conditions become severe, create safety concerns, or adversely affect drainage or usability.

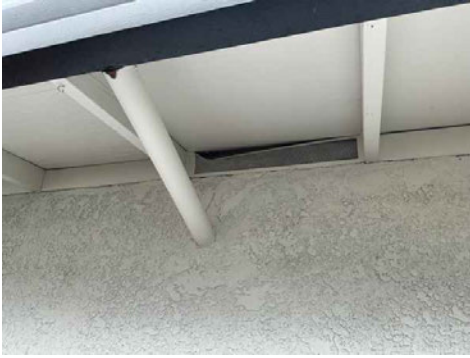
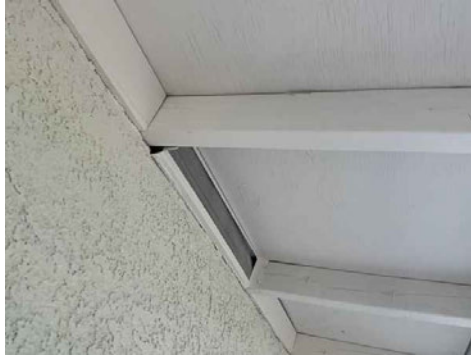
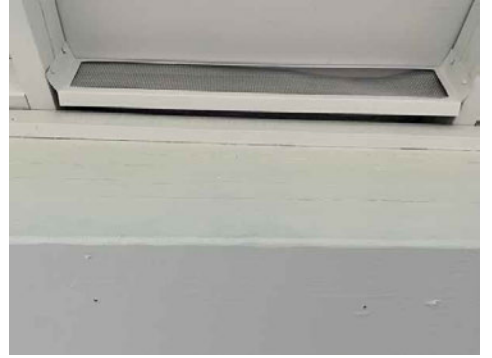
3.4.1 Eaves, Soffits and Fascia

SOFFIT VENT SCREEN DEFICIENCIES

Observation: One or more soffit vent screens were observed to be poorly fitted, displaced, or not fully secured at the time of inspection.

Implication: Gaps or displaced vent screens may allow insect, bird, rodent, or debris entry into the soffit or attic areas. Poorly fitted vents may also reduce the intended protection of the attic ventilation system.

Recommendation: Recommend repair or replacement of the affected soffit vent screens by a qualified contractor or handyman to ensure the vents are properly secured, adequately fitted, and remain free of obstruction.

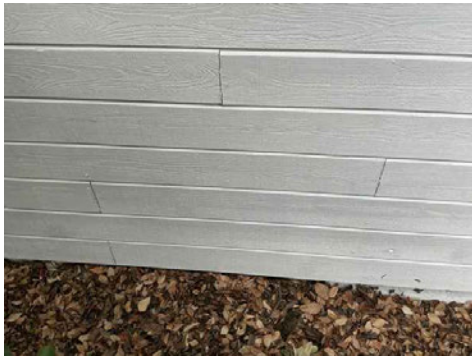
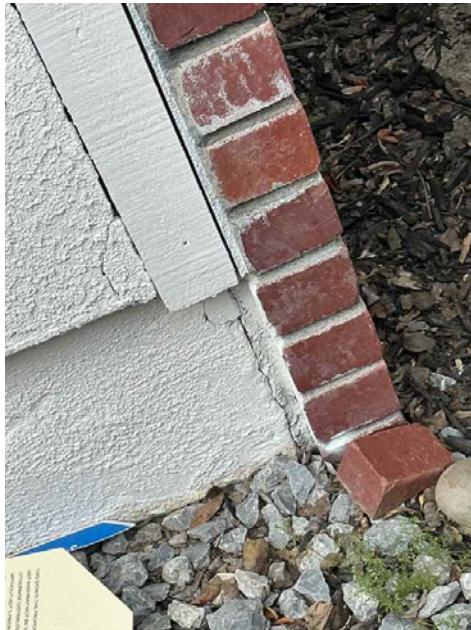
3.5.1 Siding, Flashing and Trim

UNSEALED EXTERIOR PENETRATIONS

Gaps, openings, or incomplete sealing were observed at exterior penetrations and/or cladding transitions.

Unsealed penetrations may allow moisture intrusion, pest entry, air leakage, or concealed deterioration over time.

Recommend sealing and corrective repairs by a qualified contractor as needed.

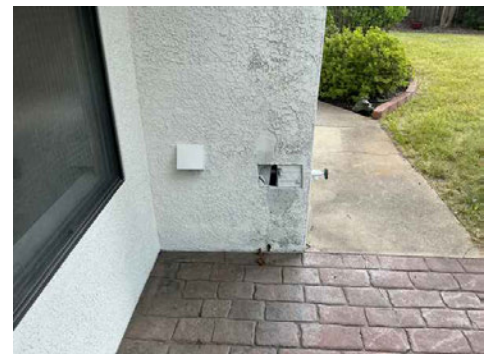
3.5.2 Siding, Flashing and Trim

UNSEALED STUCCO WALL PENETRATION / PRIOR PLUMBING REPAIR

Observation: A prior plumbing repair was observed at the exterior stucco wall. The wall opening was not properly sealed, patched, or finished at the time of inspection.

Implication: Openings in exterior stucco can allow moisture, pests, and debris to enter the wall assembly. Continued exposure may contribute to concealed moisture damage, deterioration of sheathing or framing, and damage to the surrounding stucco system.

Recommendation: Recommend repair by a qualified stucco contractor or qualified exterior wall contractor. The wall opening should be properly sealed, patched, weatherproofed, and finished to match the surrounding exterior wall surface.

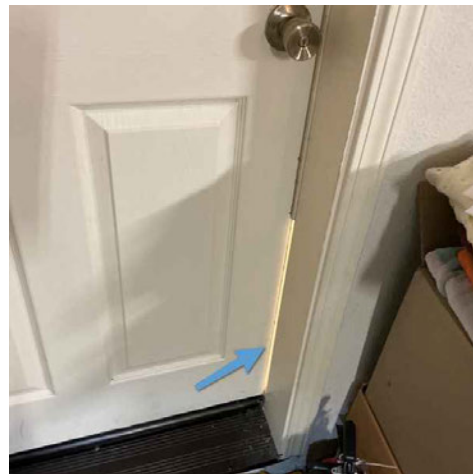
3.6.1 Exterior Doors

WEATHERSTRIPPING DEFICIENCY

Deficient, damaged, incomplete, or missing weatherstripping was observed at exterior door assemblies.

Inadequate weatherstripping may allow air leakage, moisture intrusion, pest entry, and reduced energy efficiency.

Recommend replacement or improvement of weatherstripping materials as needed to help improve weather resistance and sealing performance.

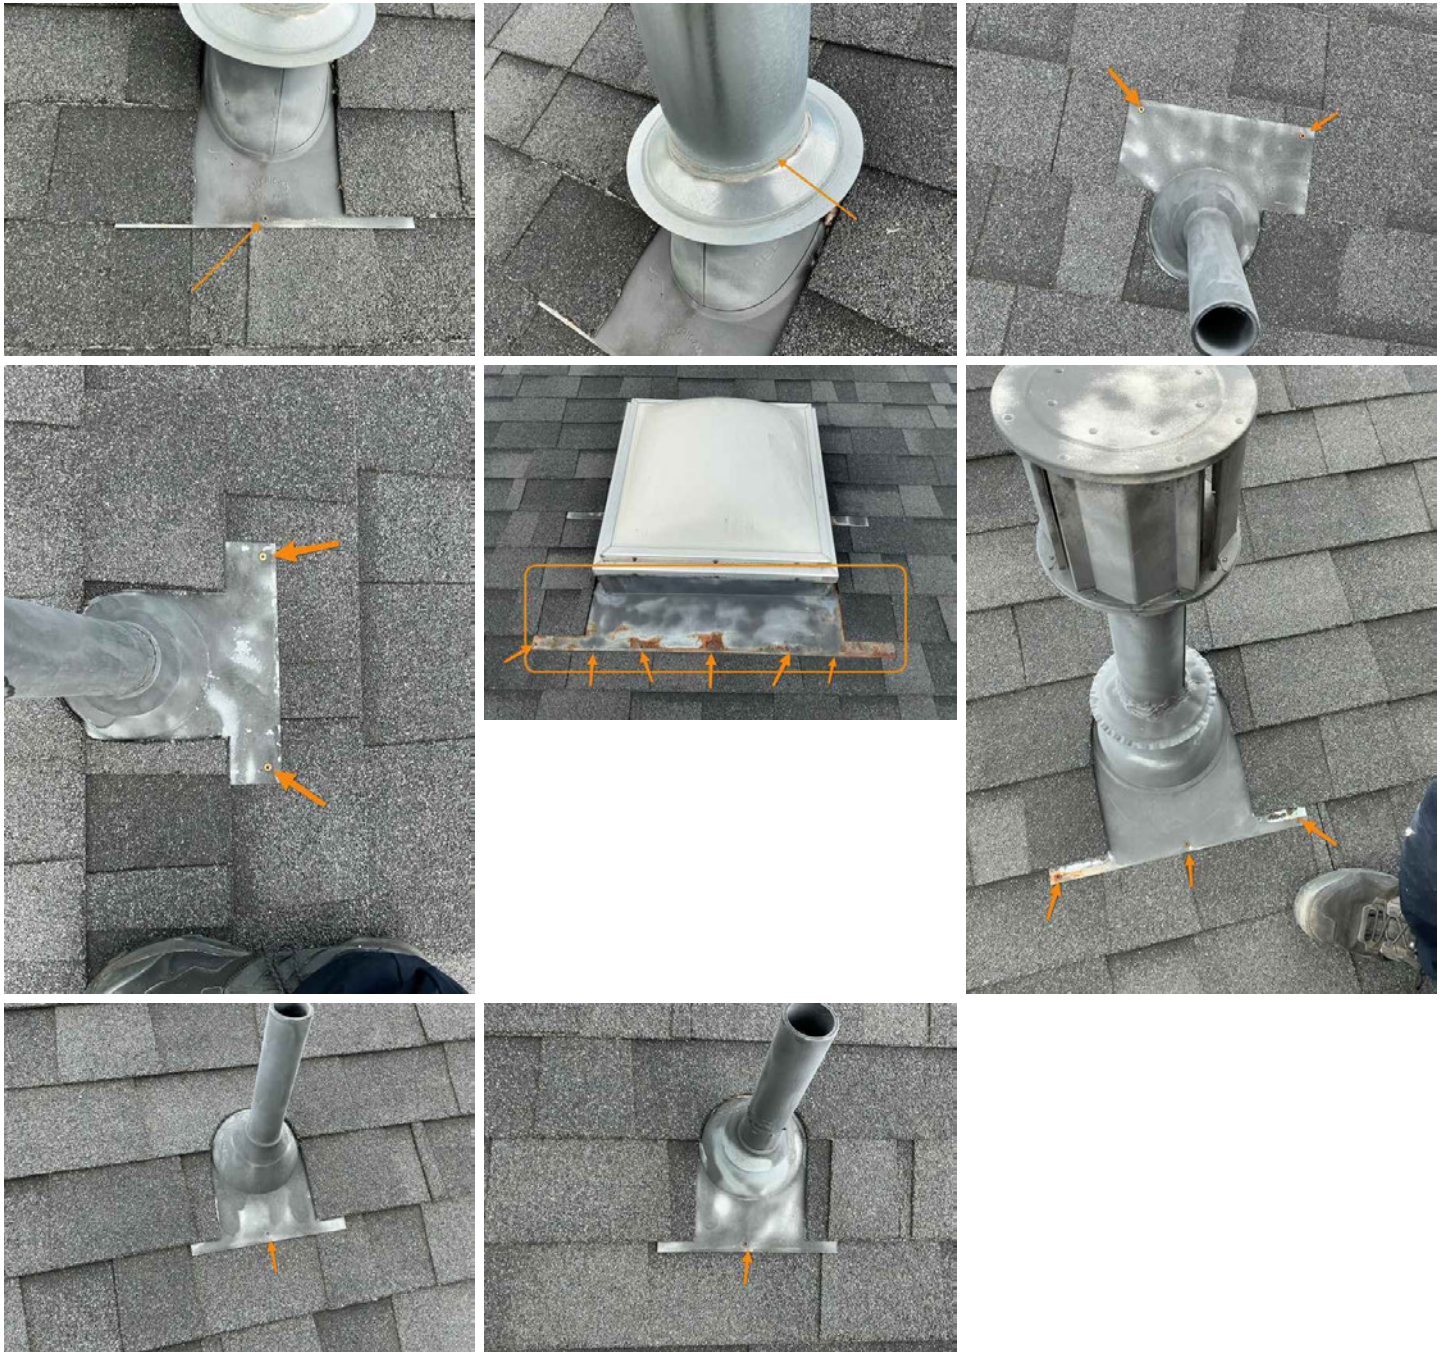
4.3.1 Flashings

Repair / Further Evaluation**EXPOSED / UNSEALED FASTENER HEADS****Observed:**

One or more exposed roofing fastener or nail heads were observed with deteriorated, missing, or insufficient sealant at the roof surface.

Exposed fastener penetrations can allow moisture intrusion over time as sealants age, shrink, crack, or deteriorate from weather exposure. While commonly considered a minor maintenance item, unsealed fasteners may contribute to localized leakage or accelerated deterioration if not periodically maintained.

Recommend resealing exposed fastener/nail heads with a compatible roofing sealant and monitoring the affected areas during routine roof maintenance.

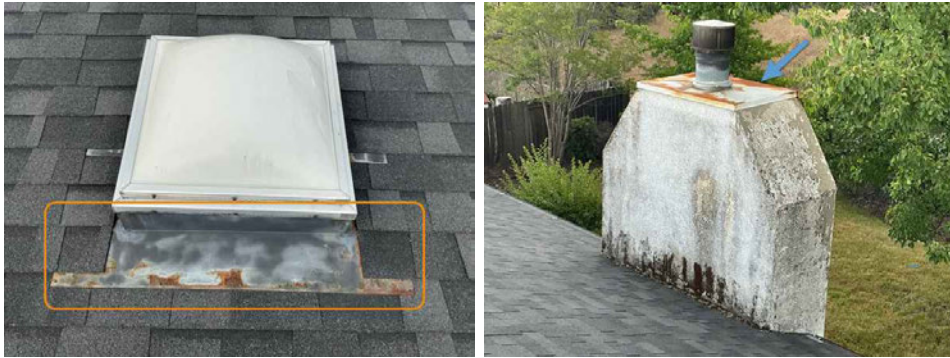
4.3.2 Flashings

CORRODED - MINOR**Observed:**

Roof flashing showed minor surface corrosion but appeared serviceable at the time of inspection.

Corrosion may accelerate deterioration of flashing materials over time if not monitored and maintained.

Recommend routine maintenance and evaluation by a qualified roofing contractor if corrosion worsens or leakage develops.

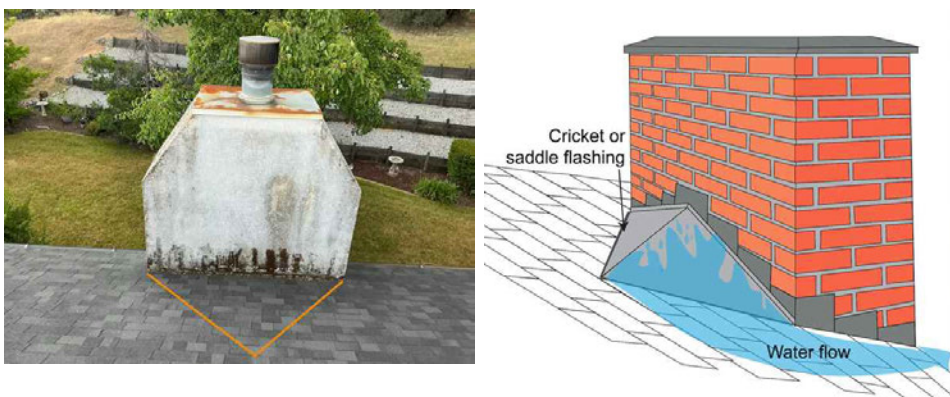
4.4.1 Skylights, Chimneys and Roof Penetrations

CHIMNEY CRICKET FLASHING – MISSING OR IMPROPER**Observed:**

The chimney cricket/diverter flashing appeared missing, undersized, or improperly installed at the uphill side of the chimney structure.

Improper chimney cricket flashing may allow debris accumulation and increase the potential for moisture intrusion at roof-to-chimney transitions.

Recommend correction by a qualified roofing contractor.

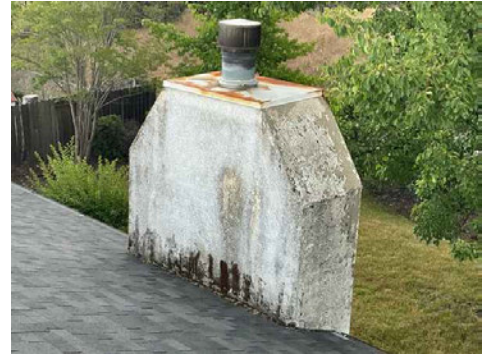
4.4.2 Skylights, Chimneys and Roof Penetrations

METAL CHIMNEY – MINOR SURFACE CORROSION OBSERVED

Minor surface corrosion was observed at metal chimney components.

Surface corrosion is common with age and weather exposure but may progress if not periodically monitored and maintained.

Recommend routine monitoring and maintenance of affected areas to help limit further deterioration.

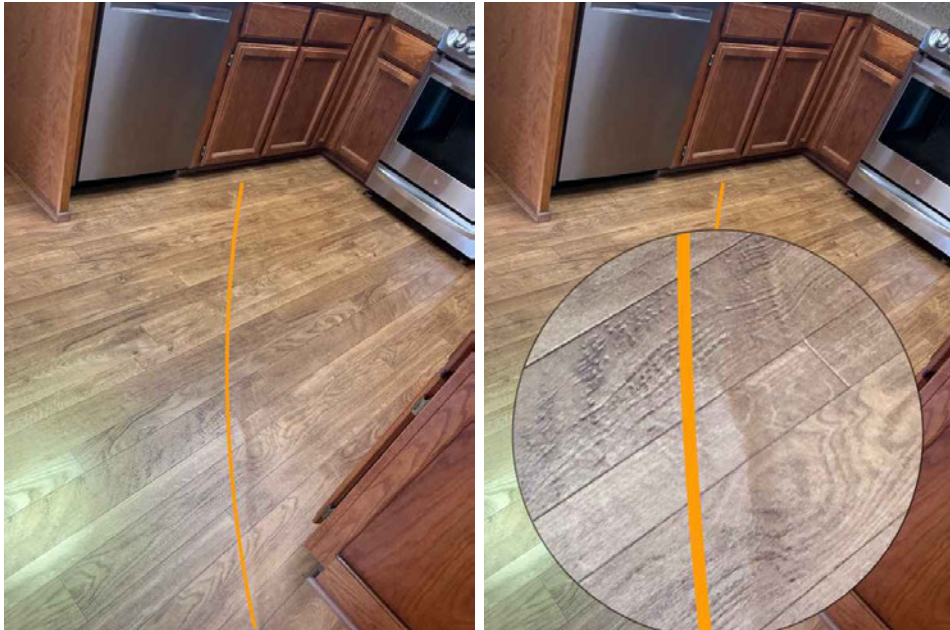
Implication: Conditions of this type can be associated with slab cracking or localized foundation movement. Minor slab cracking is common in concrete slab construction; however, significant movement or displacement may contribute to floor irregularities and potential finish-floor damage over time.

Recommendation: Recommend monitoring the area for changes and obtaining further evaluation by a qualified foundation contractor or structural specialist if movement appears progressive, floor finishes continue to separate, or additional related symptoms become apparent.

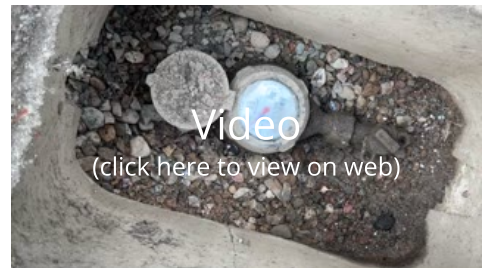
7.2.2 Main Water Shut-off Device

Implication: Unexplained meter movement may indicate leakage within concealed plumbing components, underground piping, irrigation systems, fixture components, or other portions of the water distribution system not readily visible during the inspection.

Recommendation: Recommend further evaluation by a qualified plumbing contractor to determine the source of the apparent water loss and perform repairs as needed.

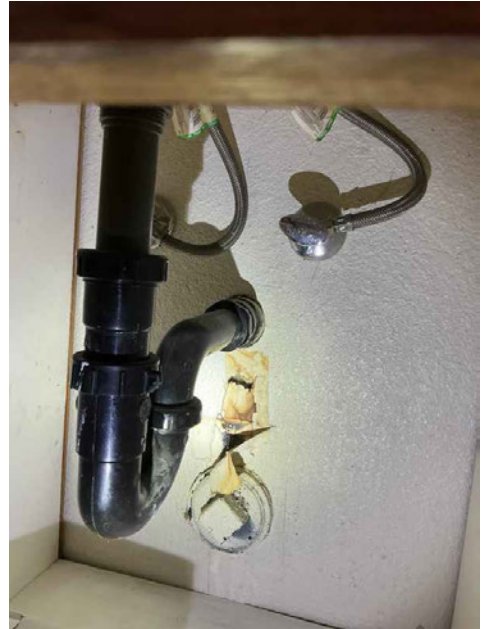
7.3.1 Drain, Waste and Vent Systems

Implication: Prior plumbing leaks can contribute to concealed moisture damage, deterioration of surrounding materials, or microbial growth if not properly corrected and dried. Staining alone does not confirm current leakage.

Recommendation: Recommend continued monitoring of the area for signs of active leakage or moisture intrusion and repair of any damaged finish materials as desired.

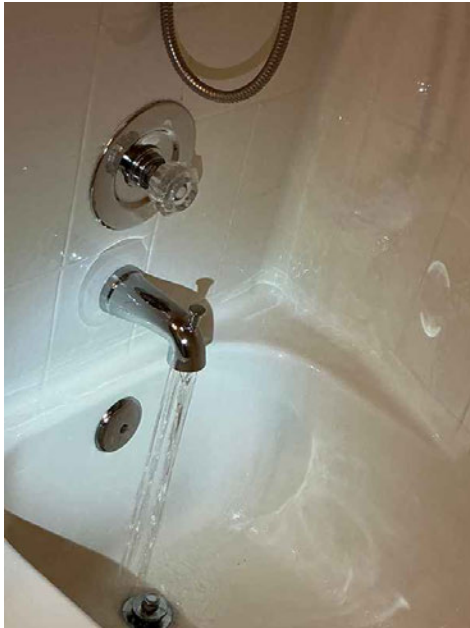
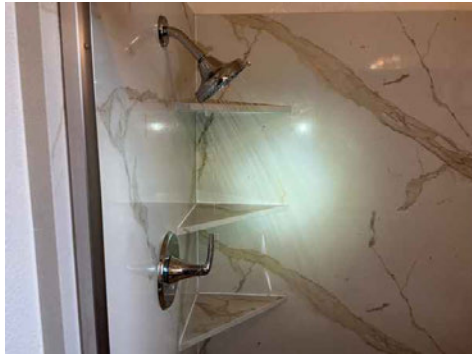
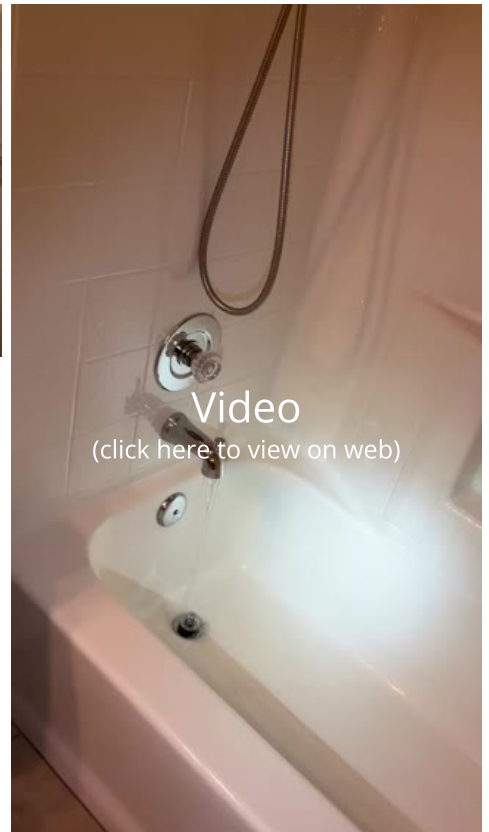
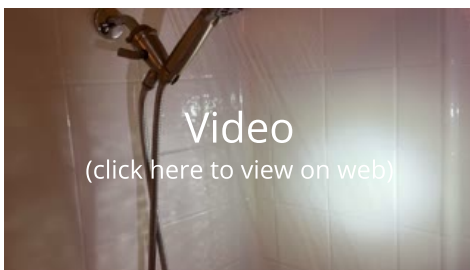
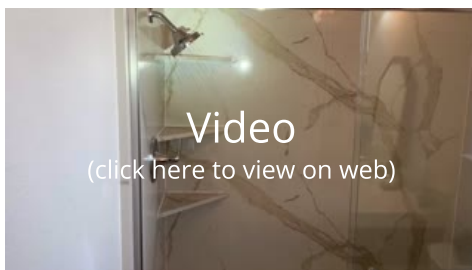
7.4.1 Water Supply, Distribution Systems and Fixtures

Implication: Reduced water pressure may affect normal fixture performance and can result from a variety of conditions, including supply restrictions, fixture-related deficiencies, aging plumbing components, partially closed valves, pressure regulator issues, mineral buildup, or other plumbing system conditions.

Recommendation: Recommend further evaluation and correction by a qualified plumbing contractor to determine the cause of the reduced water pressure and perform repairs as needed.

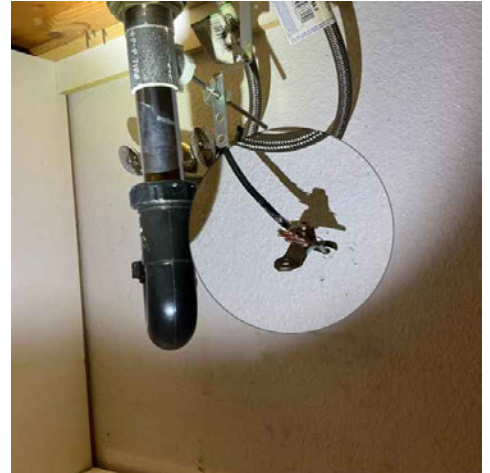
8.2.1 Main Panel, Subpanels, Service Entrance, Grounding, Main Overcurrent Device

Implication: Bonding and grounding components are intended to help reduce electrical shock hazards by maintaining continuity between metal components and the electrical grounding system. The purpose and integrity of this disconnected conductor could not be fully determined during the inspection.

Recommendation: Recommend further evaluation and repair by a qualified electrician to determine the intended function of the conductor and restore proper bonding/grounding as needed.

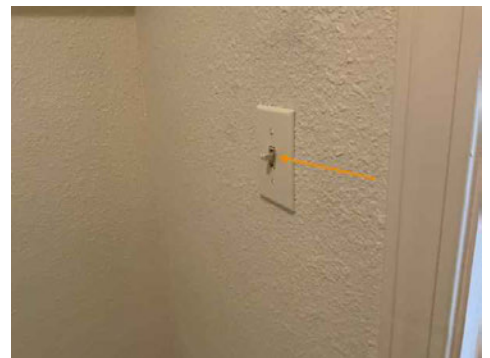
8.4.1 Lighting Fixtures, Switches and Receptacles

Implication: Worn switches may not operate reliably and can deteriorate further with continued use. In some cases, excessive wear may indicate aging internal components or prolonged use.

Recommendation: Recommend replacement of the affected switch(es) by a qualified electrician or qualified handyman to restore proper operation and improve reliability.

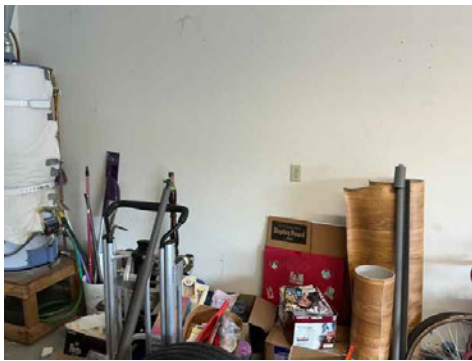
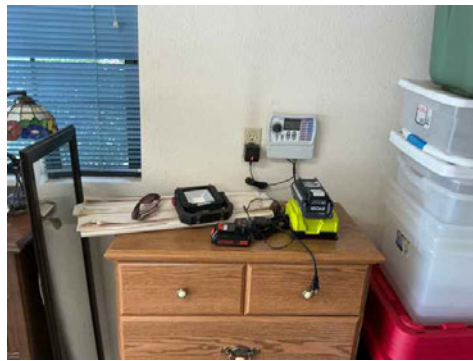
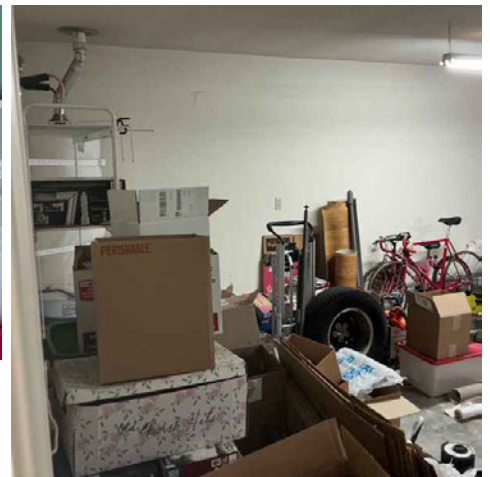
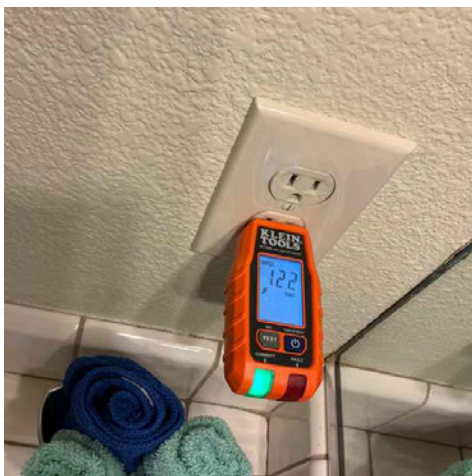
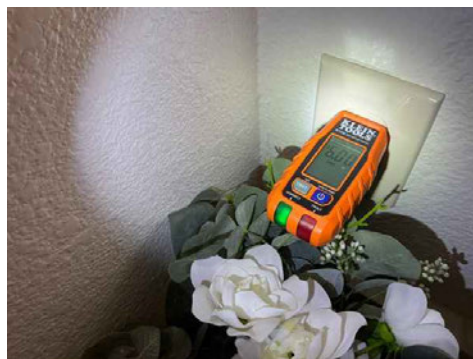
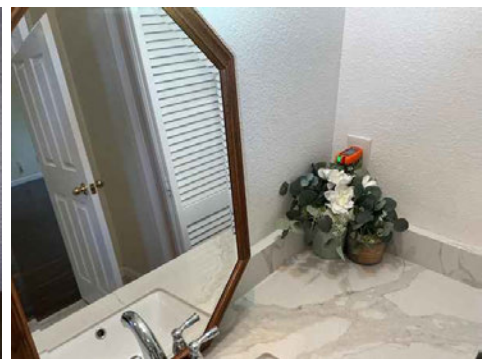
8.5.1 GFCI and AFCI

MISSING GROUND-FAULT CIRCUIT INTERRUPTER (GFCI) PROTECTION

Recommend upgrade of applicable receptacles or branch circuits with GFCI protection by a qualified licensed electrical contractor to improve electrical safety.

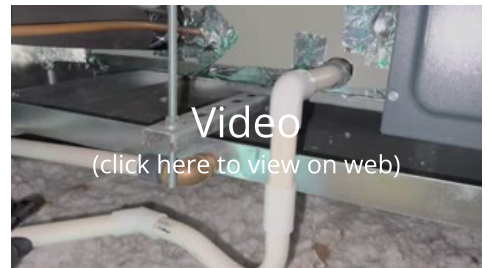
Implication: Loose condensate piping may become displaced, leak, or drain improperly during system operation. Improper condensate management can contribute to moisture intrusion, water damage, or microbial growth within surrounding building materials.

Recommendation: Recommend repair and securement of the condensate drain line by a qualified HVAC contractor to help ensure proper drainage and reliable operation of the cooling system.

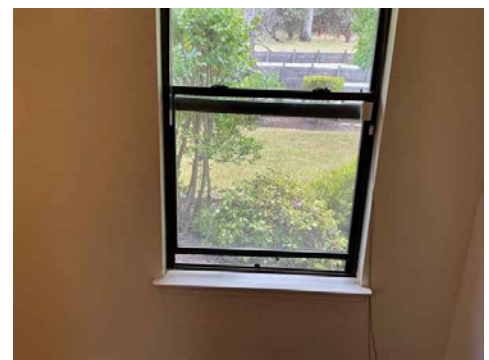
11.2.1 Windows

DAMAGED

Recommend a window professional clean, lubricate & adjust as necessary.

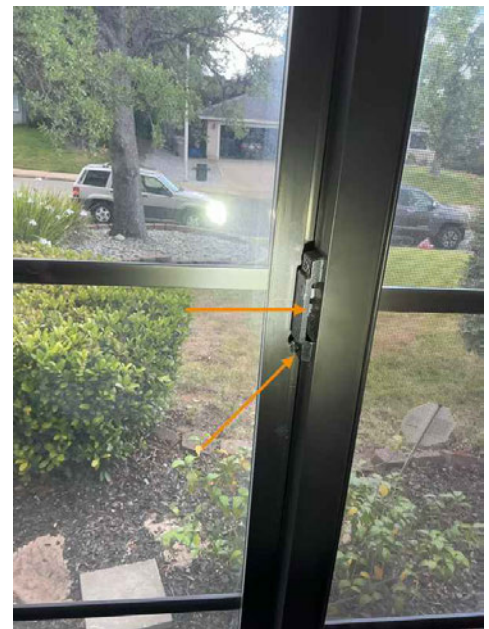
11.2.2 Windows

WINDOW - MISSING LATCH / LOCK

Recommend evaluation and correction by a qualified contractor as needed.

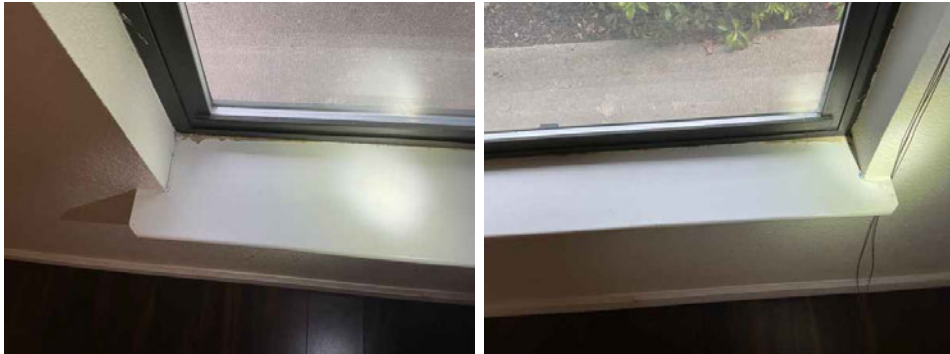
11.2.3 Windows

Implication: Window moisture intrusion can result from condensation, aging sealants, window assembly deficiencies, or intermittent exterior water penetration. Continued moisture exposure may contribute to deterioration of adjacent finish materials over time.

Recommendation: Recommend monitoring the affected areas for signs of active leakage or continued deterioration and repair/seal affected window components and finish materials as needed.

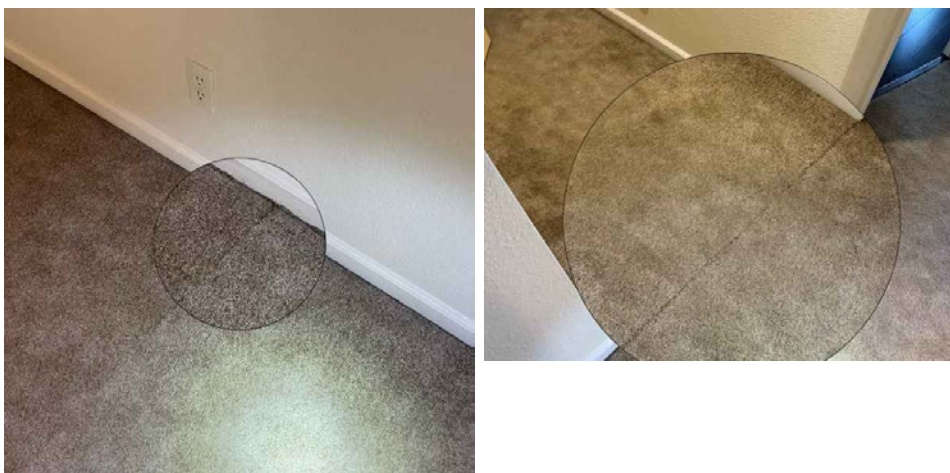
11.3.1 Floors

Implication: Visible seams are commonly associated with normal installation characteristics, wear, shrinkage, or minor separation of carpet materials over time. Depending on conditions, seams may become more noticeable with continued use.

Recommendation: Recommend monitoring and repair by a qualified flooring contractor if seam separation worsens, creates a trip hazard, or becomes a cosmetic concern.

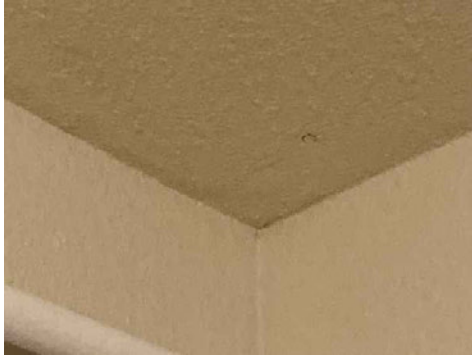
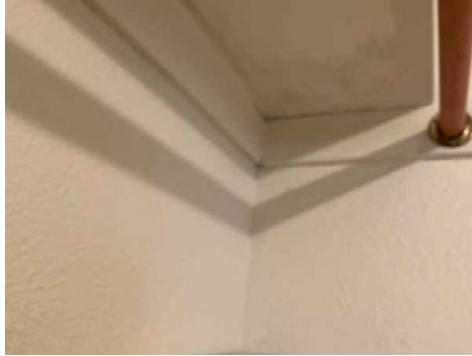
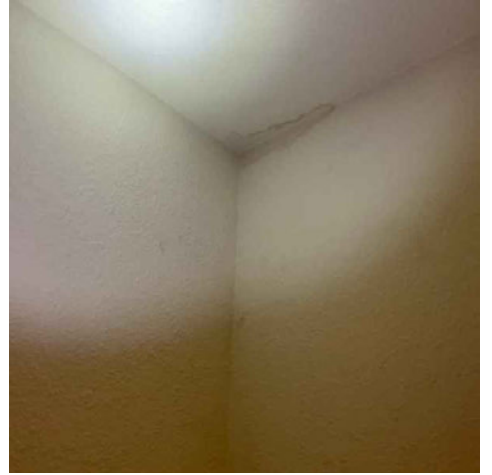
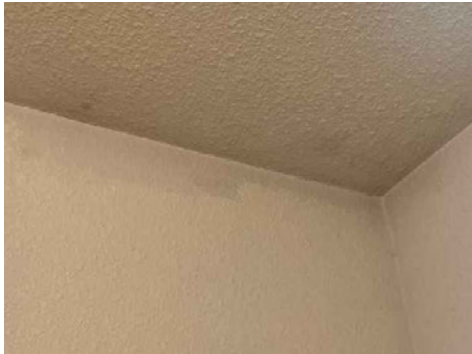
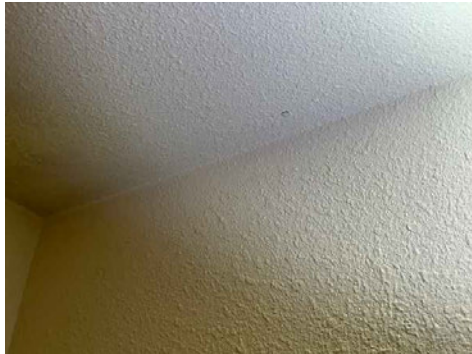
11.5.1 Ceilings

STAIN(S) ON CEILING

Recommend determining whether staining is historical or indicative of active moisture intrusion and repair as needed.

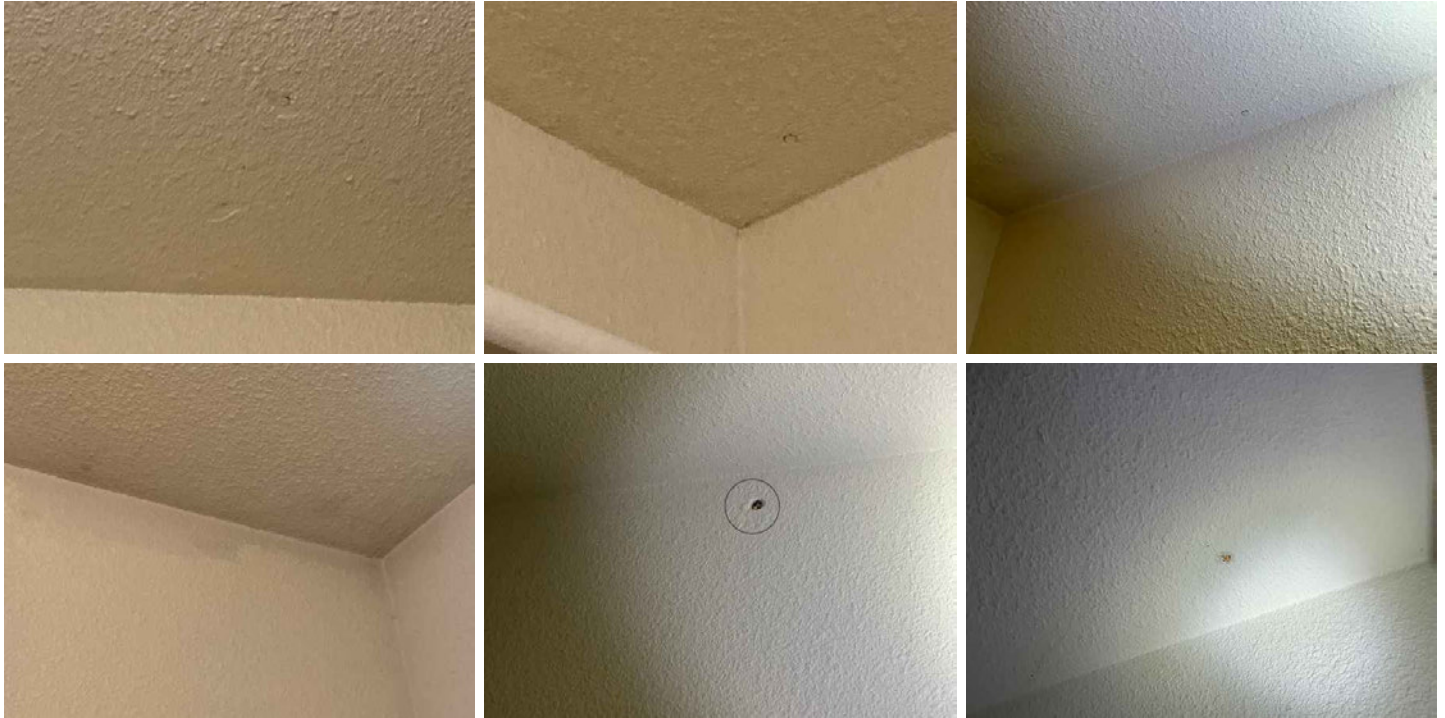
11.5.2 Ceilings

Implication: Nail pops are commonly associated with minor framing movement, seasonal expansion and contraction, or normal settling over time. These conditions are typically cosmetic in nature.

Recommendation: Recommend repair and touch-up as desired by a qualified drywall contractor or handyman during routine maintenance or future interior cosmetic improvements.

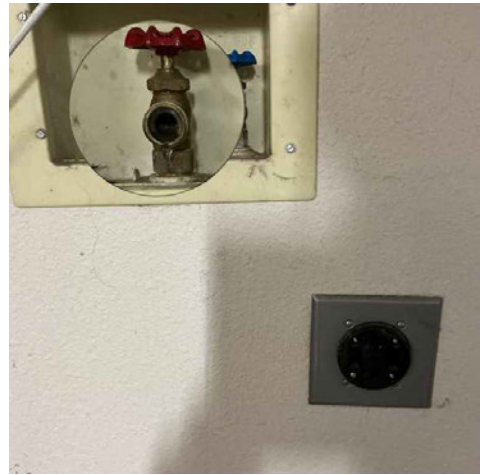
14.1.2 General

LAUNDRY SUPPLY LEAKAGE OBSERVED

Recommend repair of leaking laundry plumbing components.
