RESIDENTIAL REINSPECTION
Riviera Dr, Redding, CA 96001
03/10/2026

Reinspection – Limited Scope Verification

Summary of Reinspection Findings

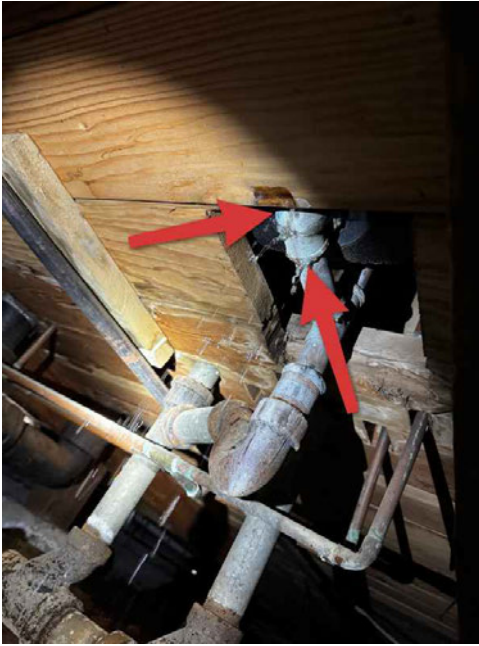
Location: Primary Bath

A drain, waste and/or vent pipe showed signs of a leak. Recommend a qualified plumber evaluate and repair.

Contact a qualified plumbing contractor.

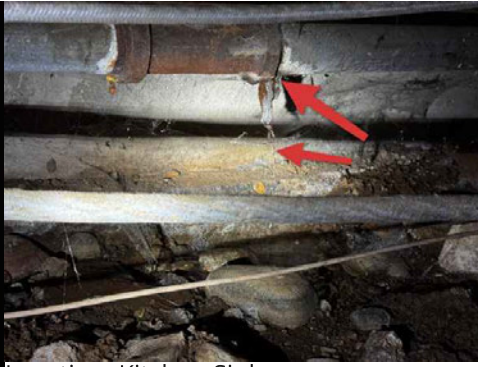
Location: Kitchen Sink

Wastewater drain piping serving the shower and sink was observed to be severely deteriorated due to corrosion consistent with electrolysis. The affected piping appears compromised and wastewater discharge onto the ground was observed.

Discharge of wastewater can create unsanitary conditions and may expose occupants to sewage contamination, along with increased moisture and damage within the crawlspace. This condition represents a significant plumbing defect and should be evaluated and repaired by a qualified plumbing contractor as soon as possible.

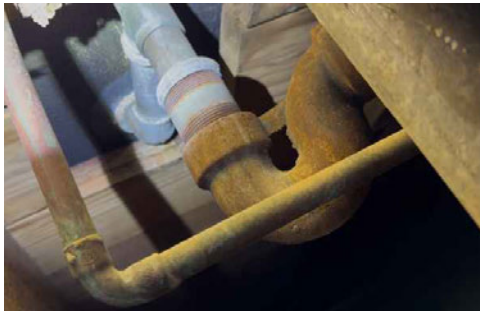
While the shower appears to be functioning without active leakage, the observed piping configuration does not align with the scope of work described in the invoice.

Master tub plumbing (appears original to the home)

Recommend the client seek clarification from the contractor who performed the work and request:

- Verification of work completed
- Supporting documentation (photos, scope details, or permits if applicable)
- Resolution of any discrepancies between invoiced scope and actual work performed

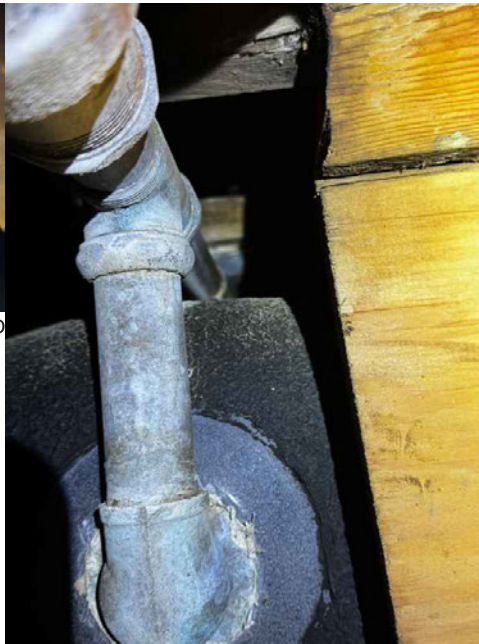
Documentation provided indicates that ABS plumbing and a new P-trap were installed at the master shower. At the time of inspection, no ABS piping was observed beneath either shower/tub assembly, and no new P-trap installation was evident in accessible areas.

This discrepancy introduces uncertainty regarding the scope and completeness of the reported repairs.

Master tub/shower with running water - no leak; no ABS repairs as invoiced

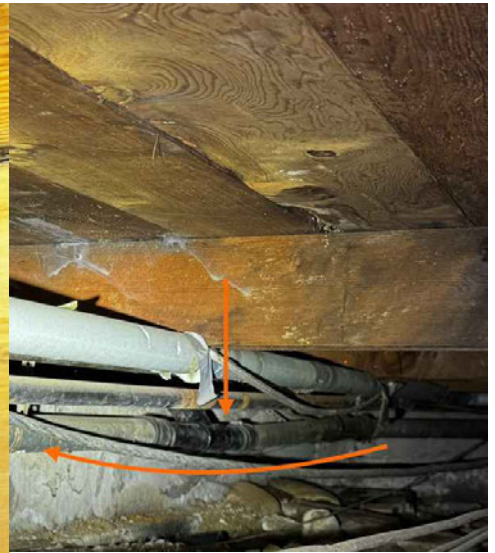
- Improper couplings: Unshielded flexible couplings used at ABS-to-galvanized transitions, which are not appropriate for this installation type
- Improper support: Missing/unfastened pipe strap resulting in inadequate support at a critical transition point
- Improper slope: Localized belly in piping at the repair area, impeding proper drainage
- Active leaks: Ongoing leakage at adjacent galvanized piping due to corrosion/electrolysis

Negative slope at repair site (arrow is direction of flow)

- Replacement of improper couplings with reinforced, material-specific transition couplings
- Installation of proper pipe supports/strapping at and near the repair
- Correction of the improper slope/belly to restore consistent drainage
- Repair or replacement of leaking galvanized piping

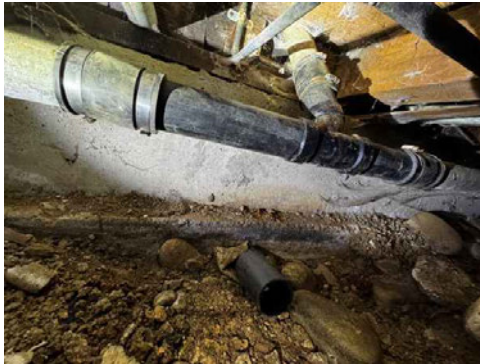
Kitchen drain line repair utilizing unshielded coupling (not consistent with standard above-ground installation practices)

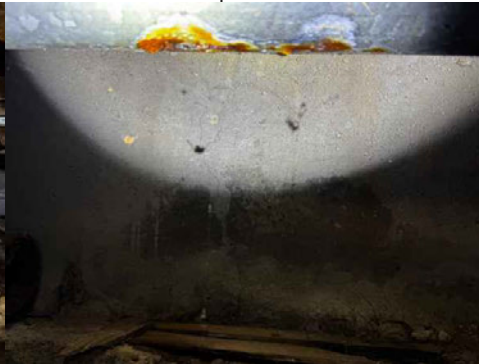
Kitchen drain line: Active leak at electrolysis <12" downstream of repair site

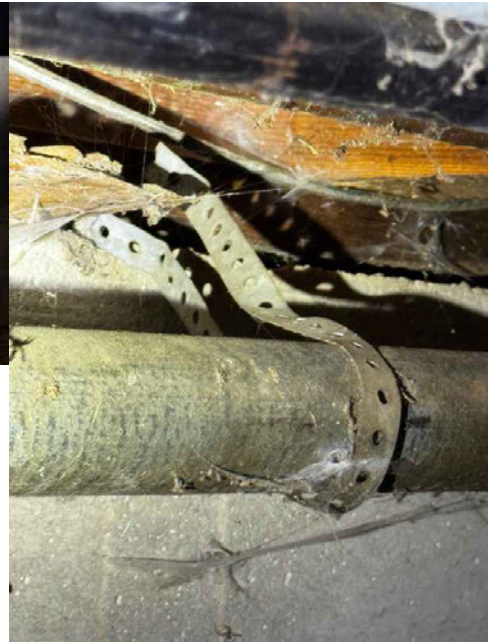
Plumbing strap at repair site not secured to joist

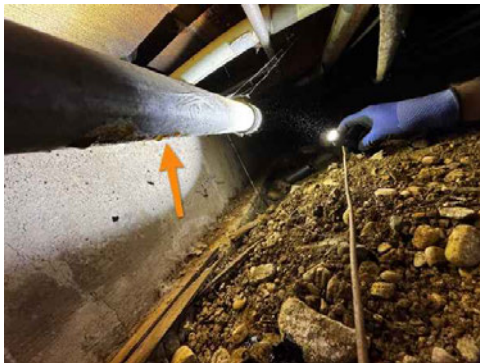
Leak downstream of kitchen sink drain repair

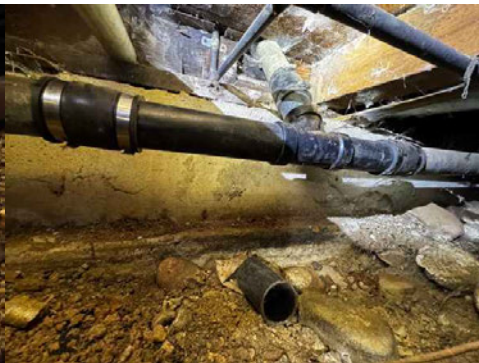
Kitchen drain line repair utilizing unshielded coupling (not consistent with standard above-ground installation practices)

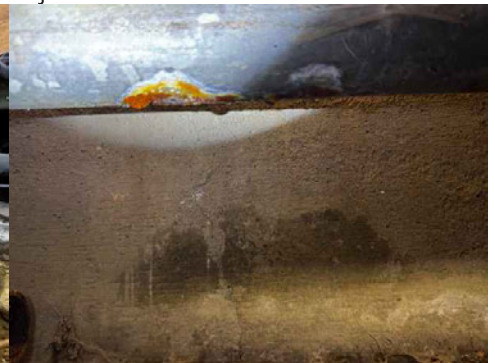
Active leak caused by electrolysis <12" downstream (east) of kitchen drain line repair

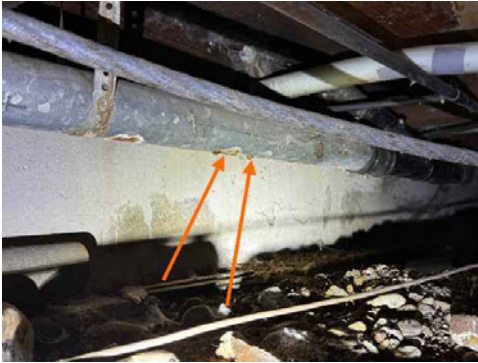
Kitchen sink drain line leaking >12" downstream of repair

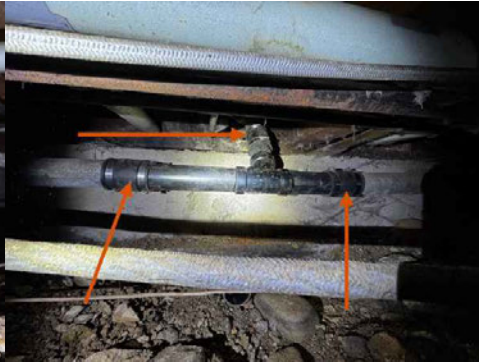
Unshielded couplings used for drain line coupling in crawl space

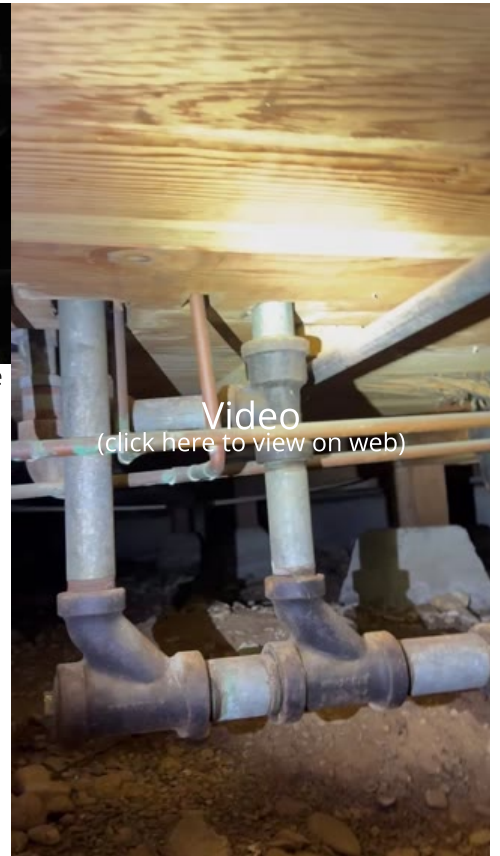
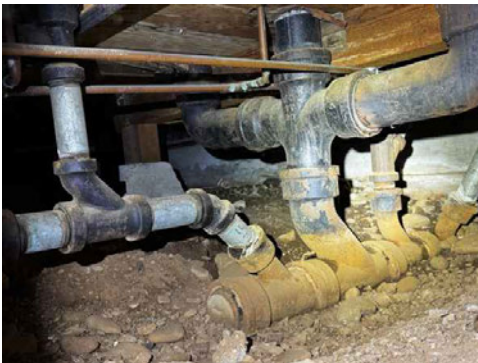
Soil stack with water running: No master tub leaks; no ABS and P-trap replaced as shown on customer invoice

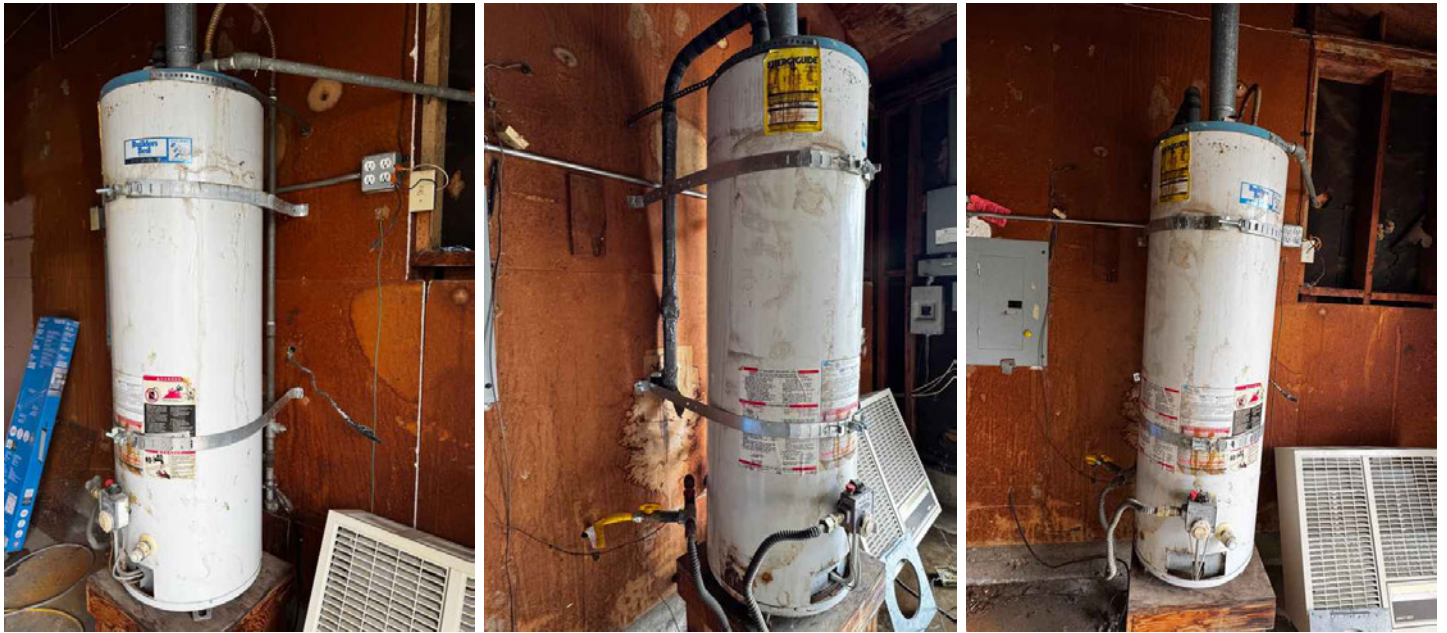
Water heater with seismic straps installed

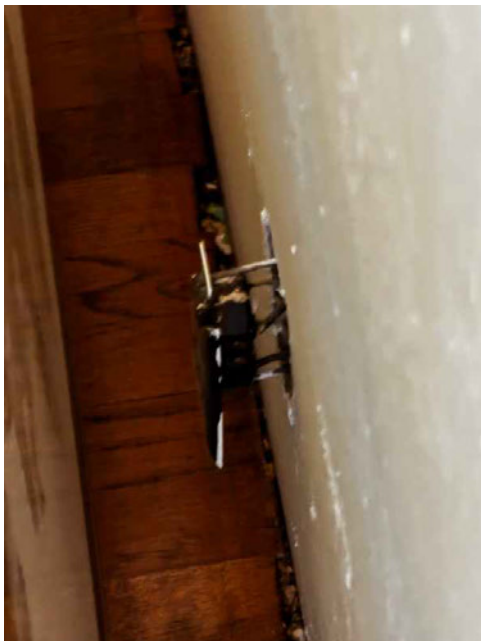
One or more receptacles are missing a cover plate. This causes short and shock risk. Recommend installation of plates.

Recommendation
Recommended DIY Project

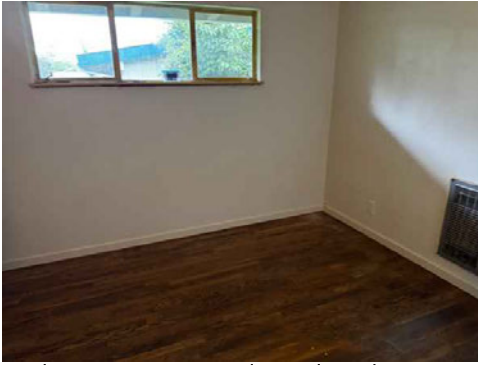
Bedroom 1- receptacle replaced; cover plate installed

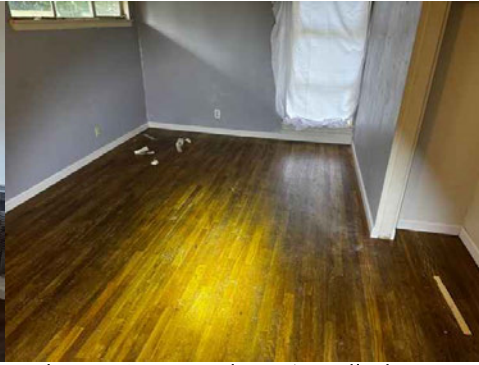
Bedroom 2 cover plates installed

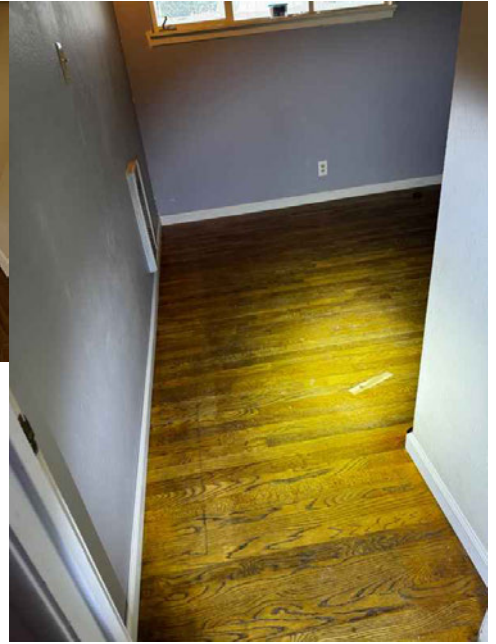
Bedroom 2 cover plates installed

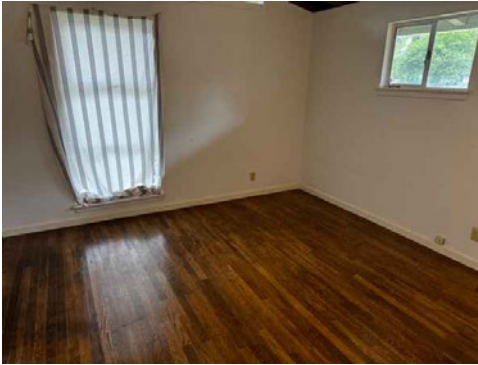
Master bedroom cover plates installed

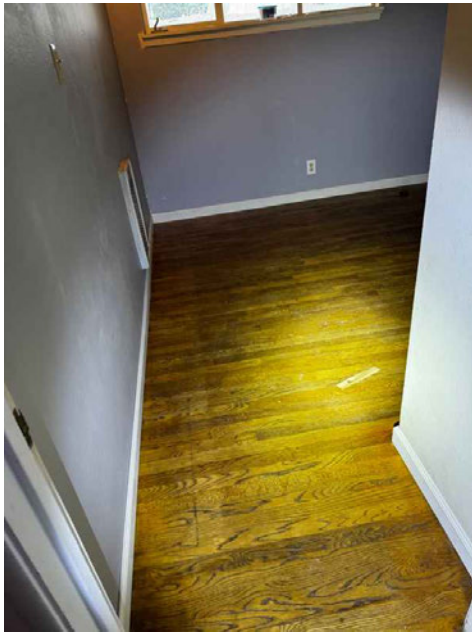
Bedroom 2 baseboards installed

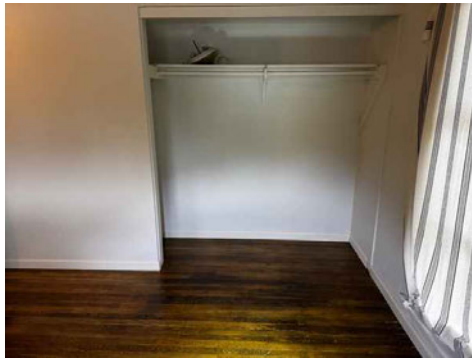
Master bedroom baseboards installed

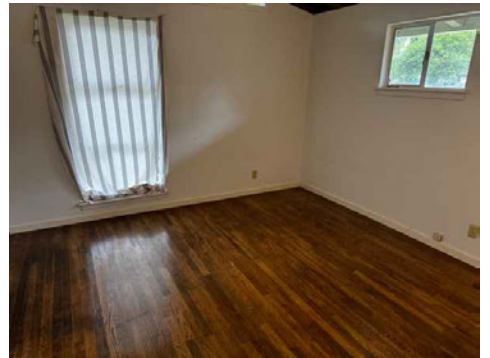
Master bedroom baseboards installed

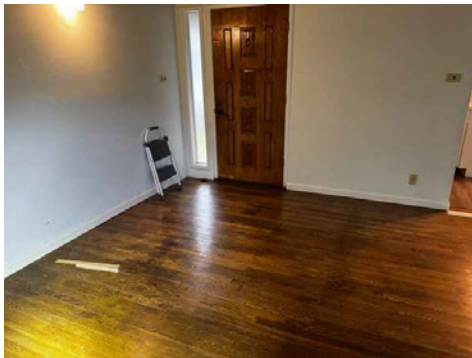
Entry baseboards installed

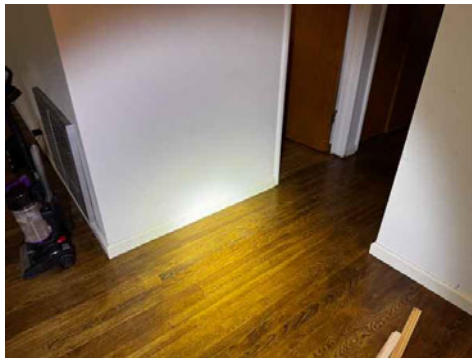
Hallway baseboards installed

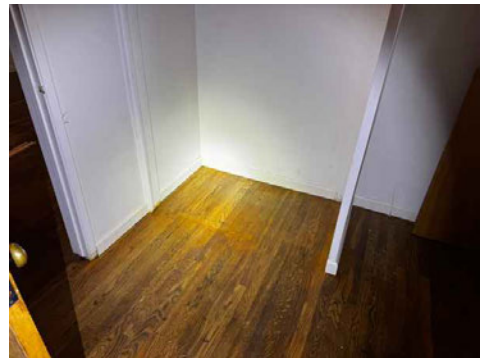
Bedroom 1 closet baseboards installed

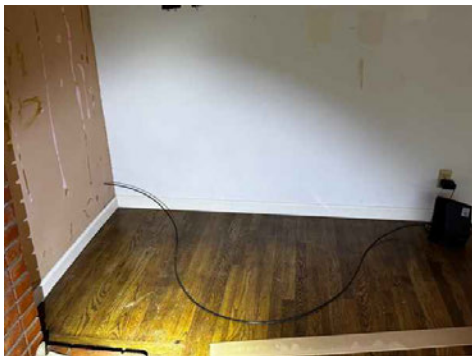
Living room south baseboards installed

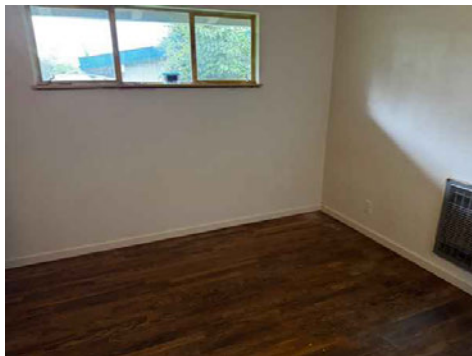
Bedroom 1 baseboards installed

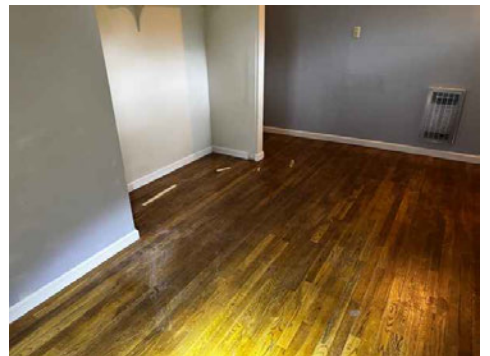
Bedroom 2 baseboards installed

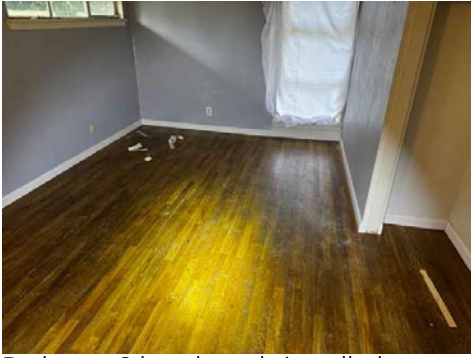
Bedroom 2 baseboards installed

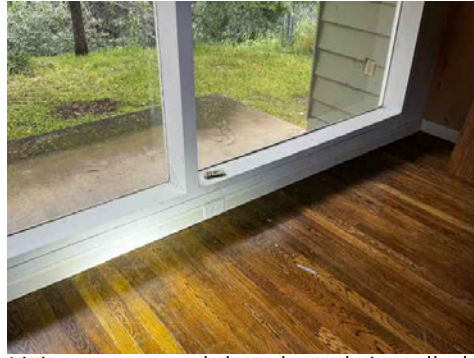
Living room north baseboards installed

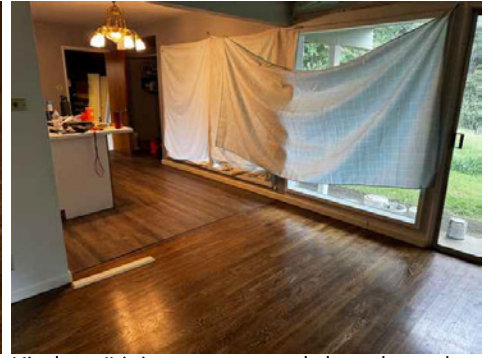
Kitchen/Living room north baseboards installed
