RESIDENTIAL REINSPECTION
REINSPECTION

Riviera Dr, Redding, CA 96001

03/10/2026

Reinspection – Limited Scope Verification

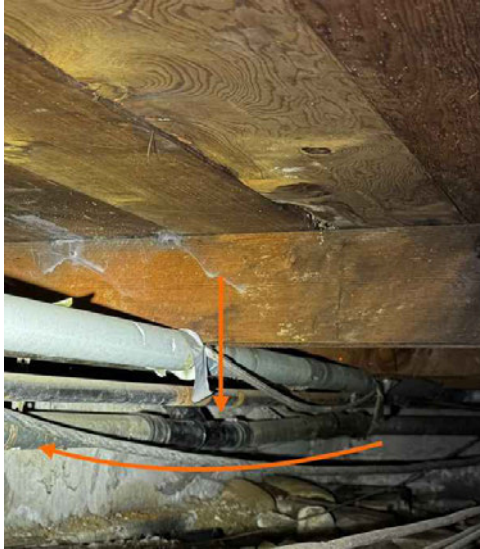
Negative slope at repair site (arrow is direction of flow)

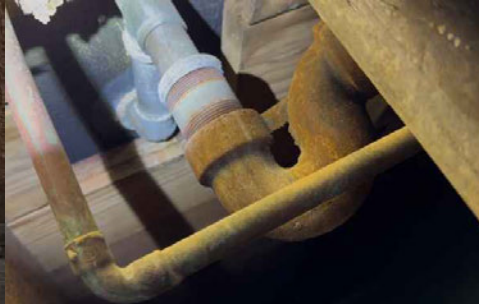
Master tub plumbing (appears original to the home)

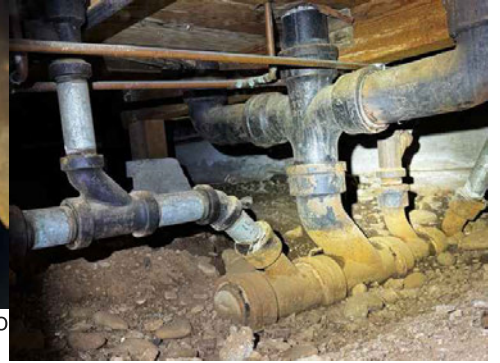
Soil stack with water running: No master tub leaks; no ABS and P-trap replaced as shown on customer invoice

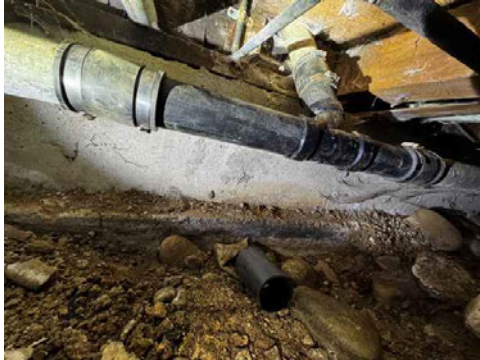
- Improper couplings: Unshielded flexible couplings used at ABS-to-galvanized transitions, which are not appropriate for this installation type
- Improper support: Missing/unfastened pipe strap resulting in inadequate support at a critical transition point
- Improper slope: Localized belly in piping at the repair area, impeding proper drainage
- Active leaks: Ongoing leakage at adjacent galvanized piping due to corrosion/electrolysis

Kitchen drain line repair utilizing unshielded coupling (not consistent with standard above-ground installation practices)

- Replacement of improper couplings with reinforced, material-specific transition couplings
- Installation of proper pipe supports/strapping at and near the repair
- Correction of the improper slope/belly to restore consistent drainage
- Repair or replacement of leaking galvanized piping

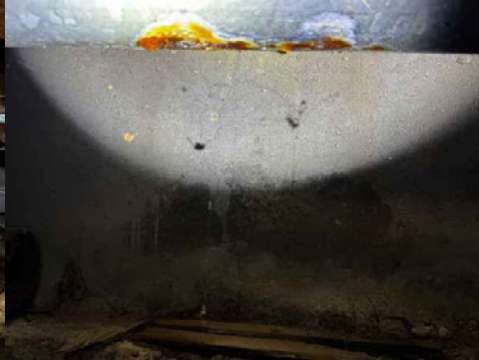
Kitchen drain line: Active leak at electrolysis <12" downstream of repair site

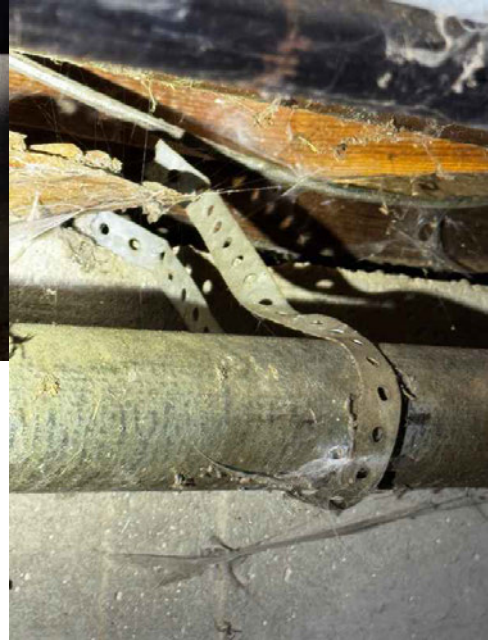
Plumbing strap at repair site not secured to joist

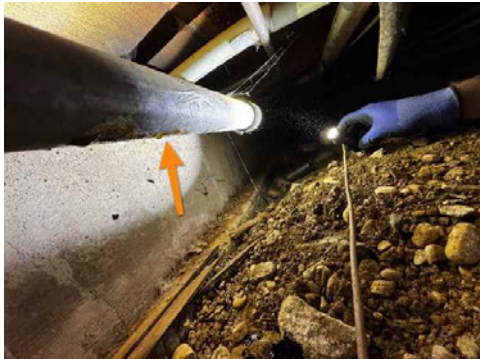
Leak downstream of kitchen sink drain repair

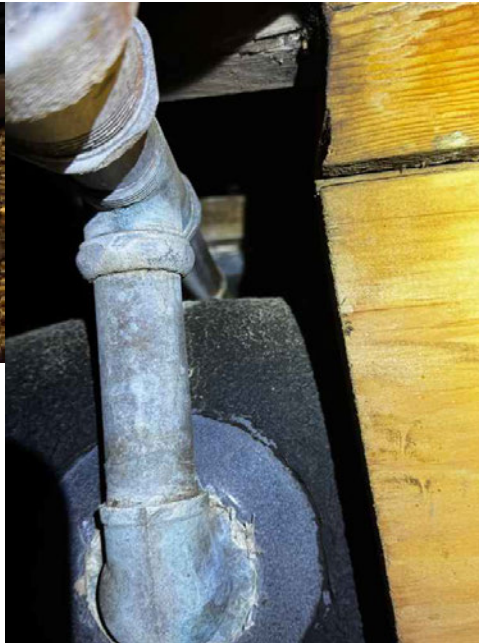
Documentation provided indicates that ABS plumbing and a new P-trap were installed at the master shower. At the time of inspection, no ABS piping was observed beneath either shower/tub assembly, and no new P-trap installation was evident in accessible areas.

Master tub/shower with running water - no leak; no ABS repairs as invoiced

Recommend the client seek clarification from the contractor who performed the work and request:

- Verification of work completed
- Supporting documentation (photos, scope details, or permits if applicable)
- Resolution of any discrepancies between invoiced scope and actual work performed

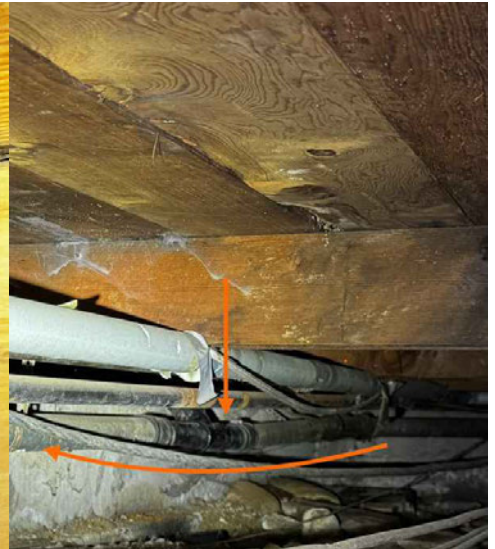
Negative slope at repair site (arrow is direction of flow)

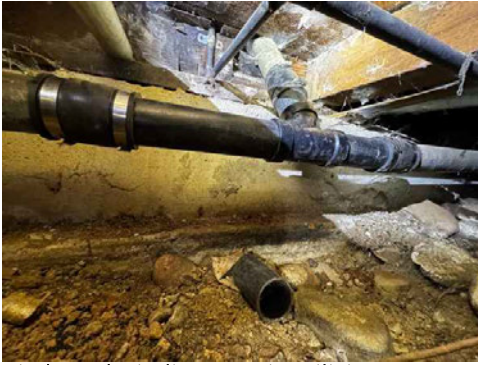
Kitchen drain line repair utilizing unshielded coupling (not consistent with standard above-ground installation practices)

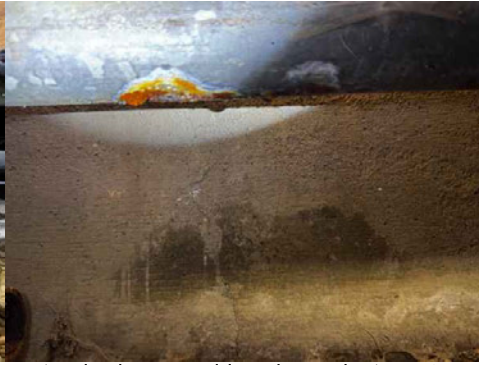
Active leak caused by electrolysis <12" downstream (east) of kitchen drain line repair

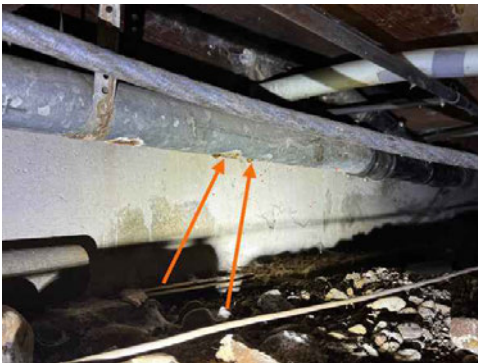
Kitchen sink drain line leaking >12" downstream of repair

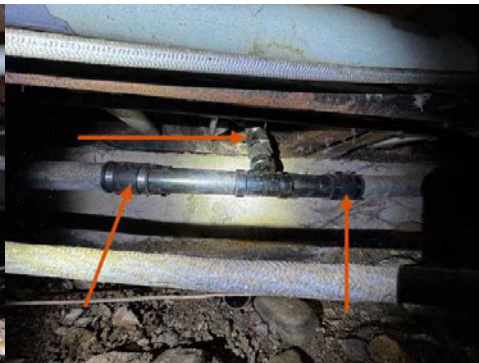
Unshielded couplings used for drain line coupling in crawl space

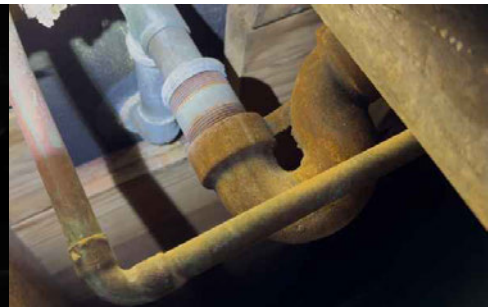
Master tub plumbing (appears original to the home)

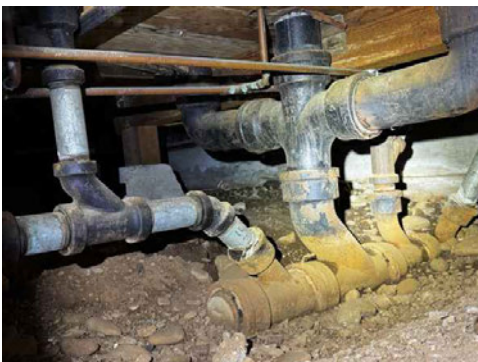
Soil stack with water running: No master tub leaks; no ABS and P-trap replaced as shown on customer invoice
