CM² SIGNATURE INSPECTION SERVICES

CM² THERMAL IMAGING ADD-ON

Spaniel Dr
Redding, CA 96003

CM² Signature Thermal Imaging Inspection

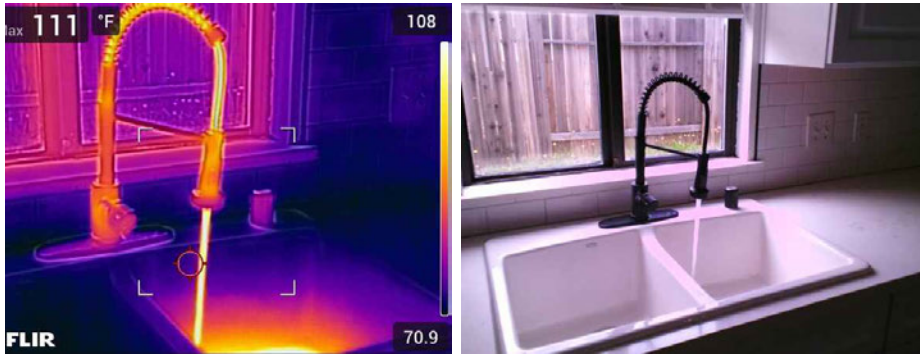
Hot Water Temperature Differential Observed: Active Hot Water Pattern Observed

Thermal imaging was utilized during operation of the plumbing fixtures. Elevated thermal patterns consistent with hot water delivery were observed at the kitchen sink fixture and accessible plumbing components at the time of inspection.

No immediate adverse condition was observed relative to accessible hot water temperature patterns at the time of inspection. Continue routine plumbing system maintenance and monitoring as needed.

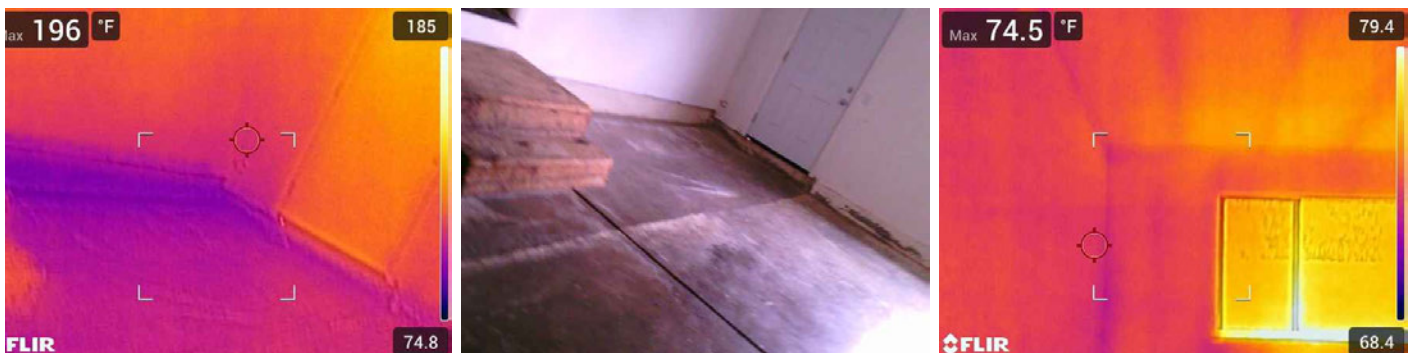
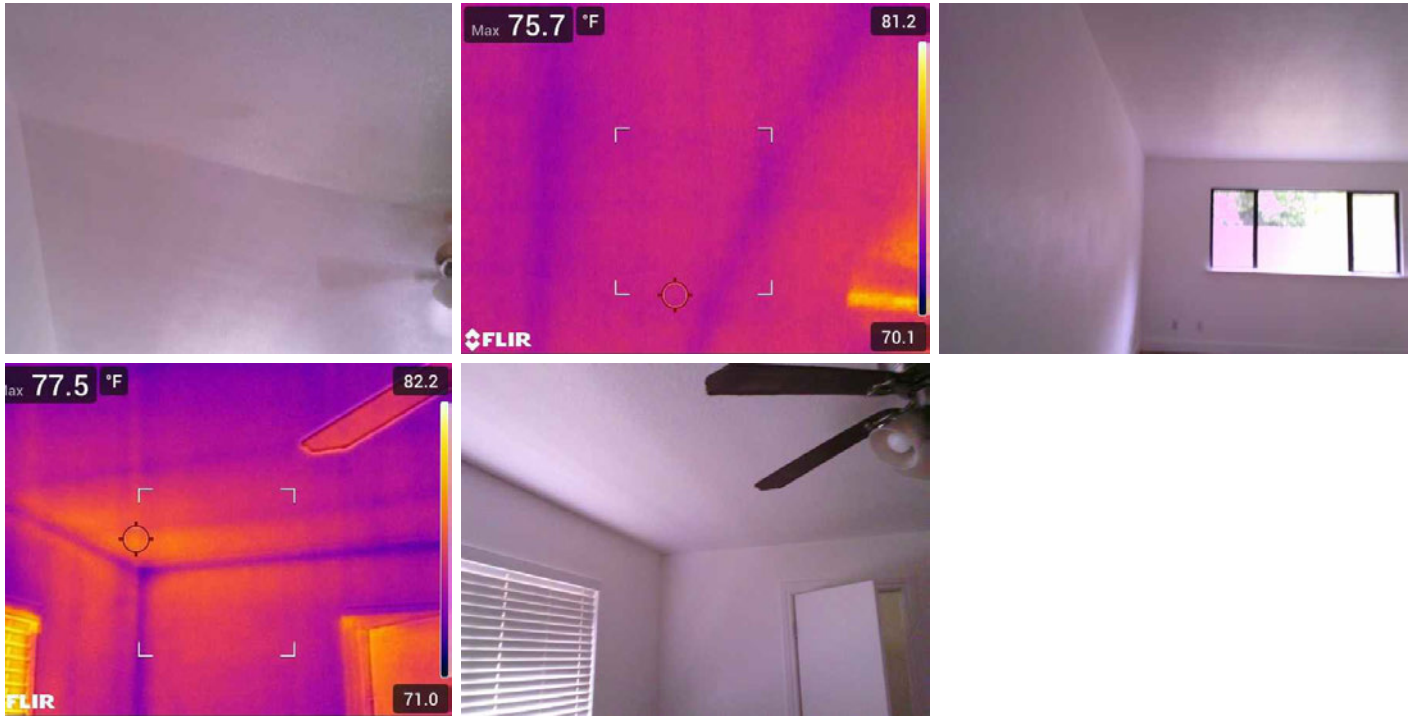
No Significant Thermal Anomalies Observed at Walls & Ceilings: No Significant Wall or Ceiling Anomalies Observed

Thermal imaging was utilized to evaluate accessible interior wall and ceiling surfaces during the time of inspection. No significant thermal anomalies, elevated moisture patterns, or irregular temperature differentials were observed at the accessible areas evaluated under the environmental conditions present at the time of inspection.

No immediate adverse condition was observed relative to accessible wall and ceiling thermal patterns at the time of inspection. Continue routine monitoring and maintenance as part of normal property stewardship.

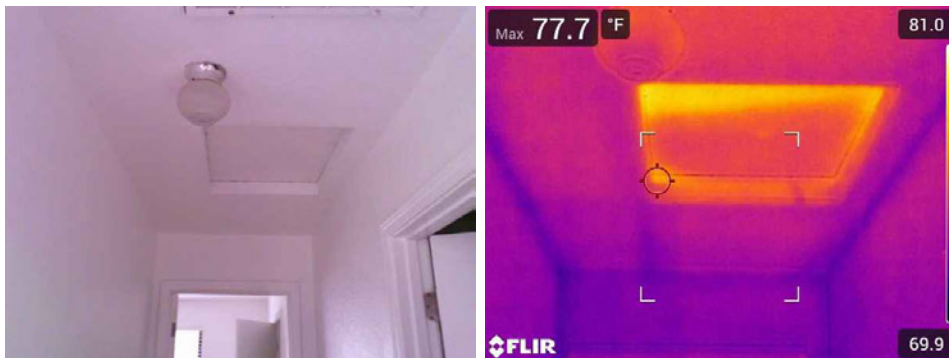
5.1.1 Roof & Walls

ELEVATED THERMAL TRANSFER AT ATTIC ACCESS

Thermal imaging identified elevated thermal transfer patterns at the attic access panel during the time of inspection. The attic access area appeared measurably warmer than adjacent finished ceiling surfaces, which may indicate missing, compressed, displaced, or insufficient insulation and/or air sealing at the attic opening.

Inadequate insulation or air sealing at attic access openings can contribute to increased energy loss, reduced HVAC efficiency, interior comfort variations, and condensation potential under certain environmental conditions. Thermal imaging identifies relative surface temperature differences only and is not a determination of exact insulation values or concealed conditions.

Recommend evaluation and improvement of insulation and air sealing at the attic access area as needed by a qualified insulation or weatherization contractor to improve thermal performance and energy efficiency.

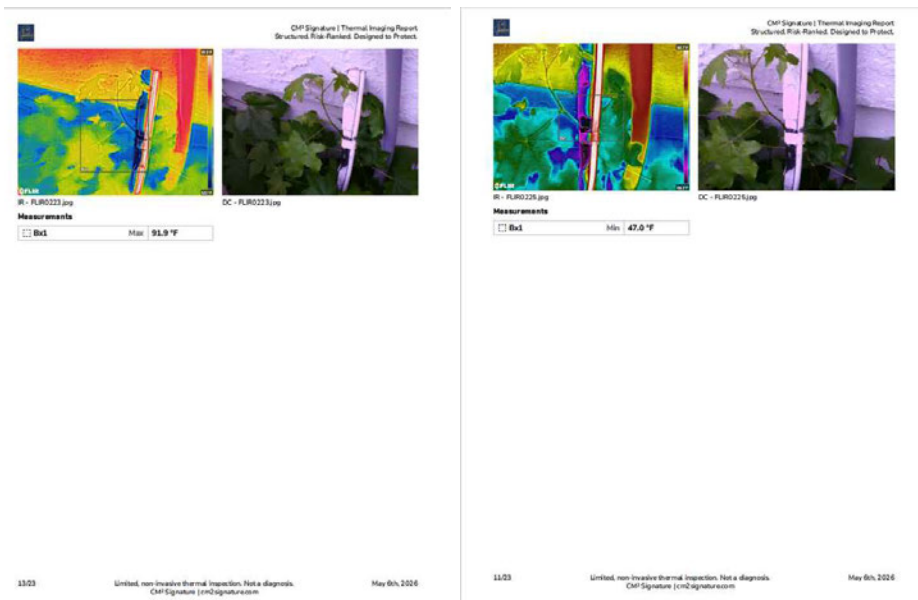
Cooling System Refrigerant Line Temperature Differential Observed: Relative Refrigerant Differential Observed

Thermal imaging was utilized during operation of the cooling system. Relative temperature differences were observed between the accessible suction and liquid refrigerant lines at the exterior condensing equipment at the time of inspection. The suction line appeared cooler than the adjacent liquid line, which is generally consistent with active cooling system operation under observed conditions.

No immediate adverse condition was observed relative to accessible refrigerant line temperature patterns at the time of inspection. Continue routine HVAC servicing and maintenance in accordance with manufacturer recommendations.
