CM² RESIDENTIAL INSPECTION

5245 Mica Ct
Redding, CA 96003

CM² Residential Signature Inspection Report

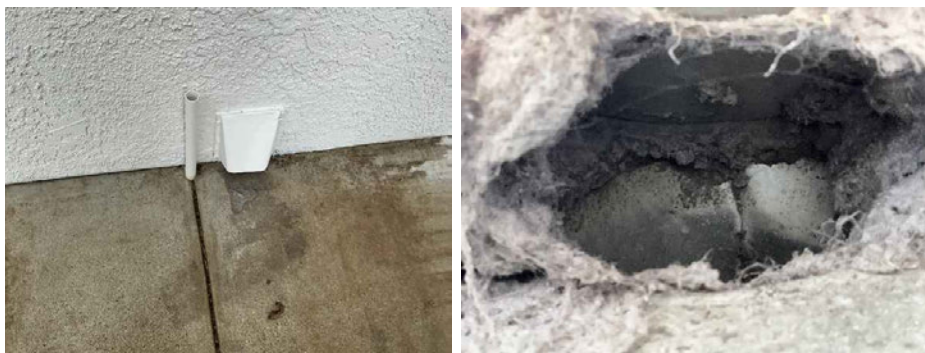
General: Dryer Exhaust Cleaning / Servicing Recommended

Periodic dryer exhaust cleaning and servicing is recommended to help maintain proper airflow and reduce lint accumulation within the exhaust system.

Lint accumulation within dryer exhaust systems can reduce drying efficiency and may contribute to elevated moisture or fire risk over time if not routinely maintained.

Recommend routine inspection and cleaning of the dryer exhaust system in accordance with manufacturer recommendations and typical maintenance practices.
