RESIDENTIAL REINSPECTION
REINSPECTION

Riviera Dr, Redding, CA 96001

03/10/2026

Reinspection – Limited Scope Verification

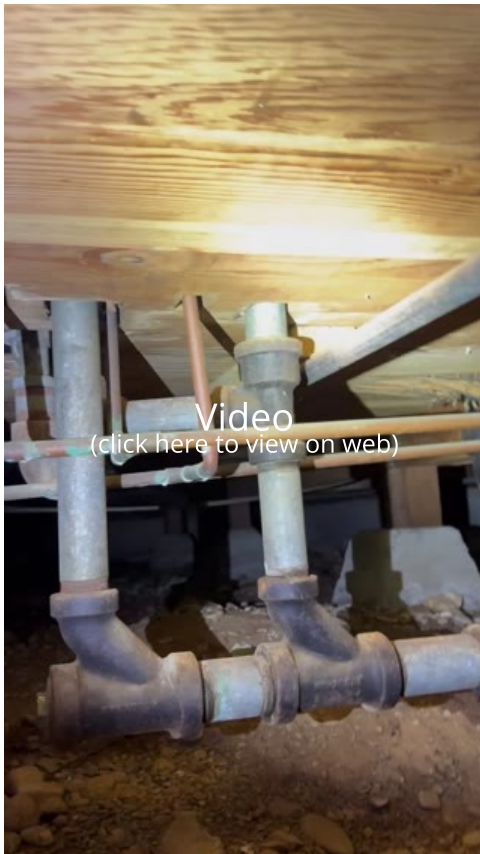
Soil stack with water running: No master tub leaks; no ABS and P-trap replaced as shown on customer invoice

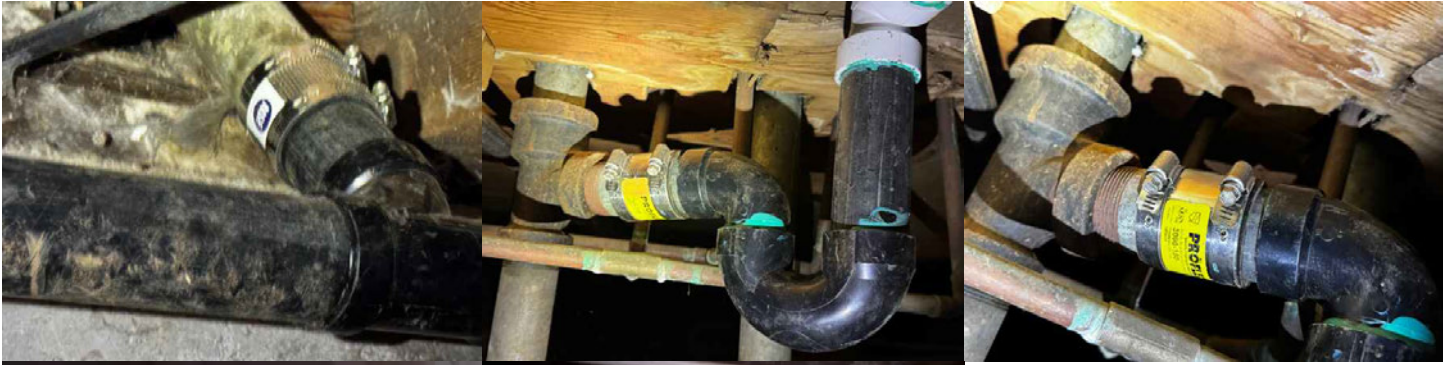
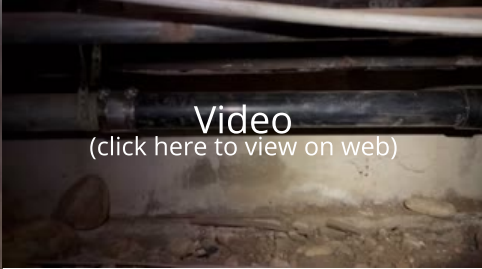
Reinspection Photos

Recent repair work was observed at the crawlspace DWV piping where ABS piping has been connected to existing galvanized steel piping using unshielded flexible rubber couplings.

- A missing/unfastened pipe strap adjacent to the repair location
- A visible belly (negative slope) in the horizontal piping at the repair
- Active leakage from galvanized piping consistent with corrosion/electrolysis at two locations within approximately 1 foot of the repair

- Improper couplings: Unshielded flexible couplings used at ABS-to-galvanized transitions, which are not appropriate for this installation type
- Improper support: Missing/unfastened pipe strap resulting in inadequate support at a critical transition point
- Improper slope: Localized belly in piping at the repair area, impeding proper drainage
- Active leaks: Ongoing leakage at adjacent galvanized piping due to corrosion/electrolysis

- Replacement of improper couplings with reinforced, material-specific transition couplings
- Installation of proper pipe supports/strapping at and near the repair
- Correction of the improper slope/belly to restore consistent drainage
- Repair or replacement of leaking galvanized piping

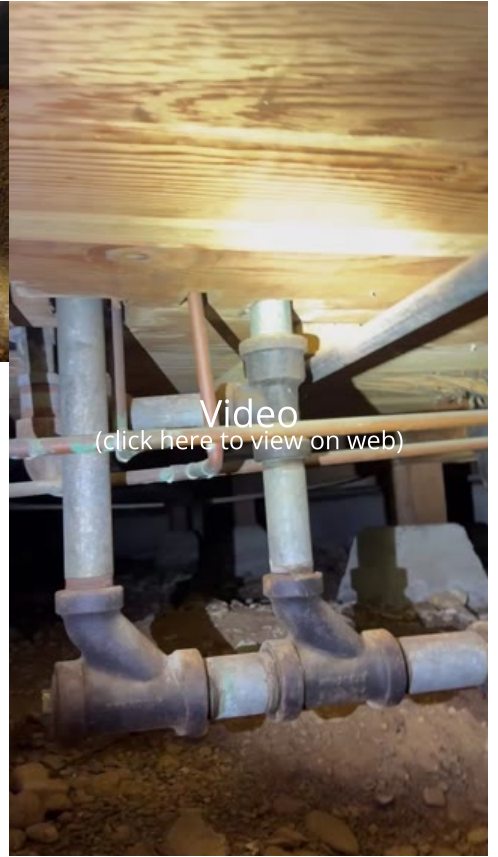
Active leak caused by electrolysis <12" downstream (east) of kitchen drain line repair

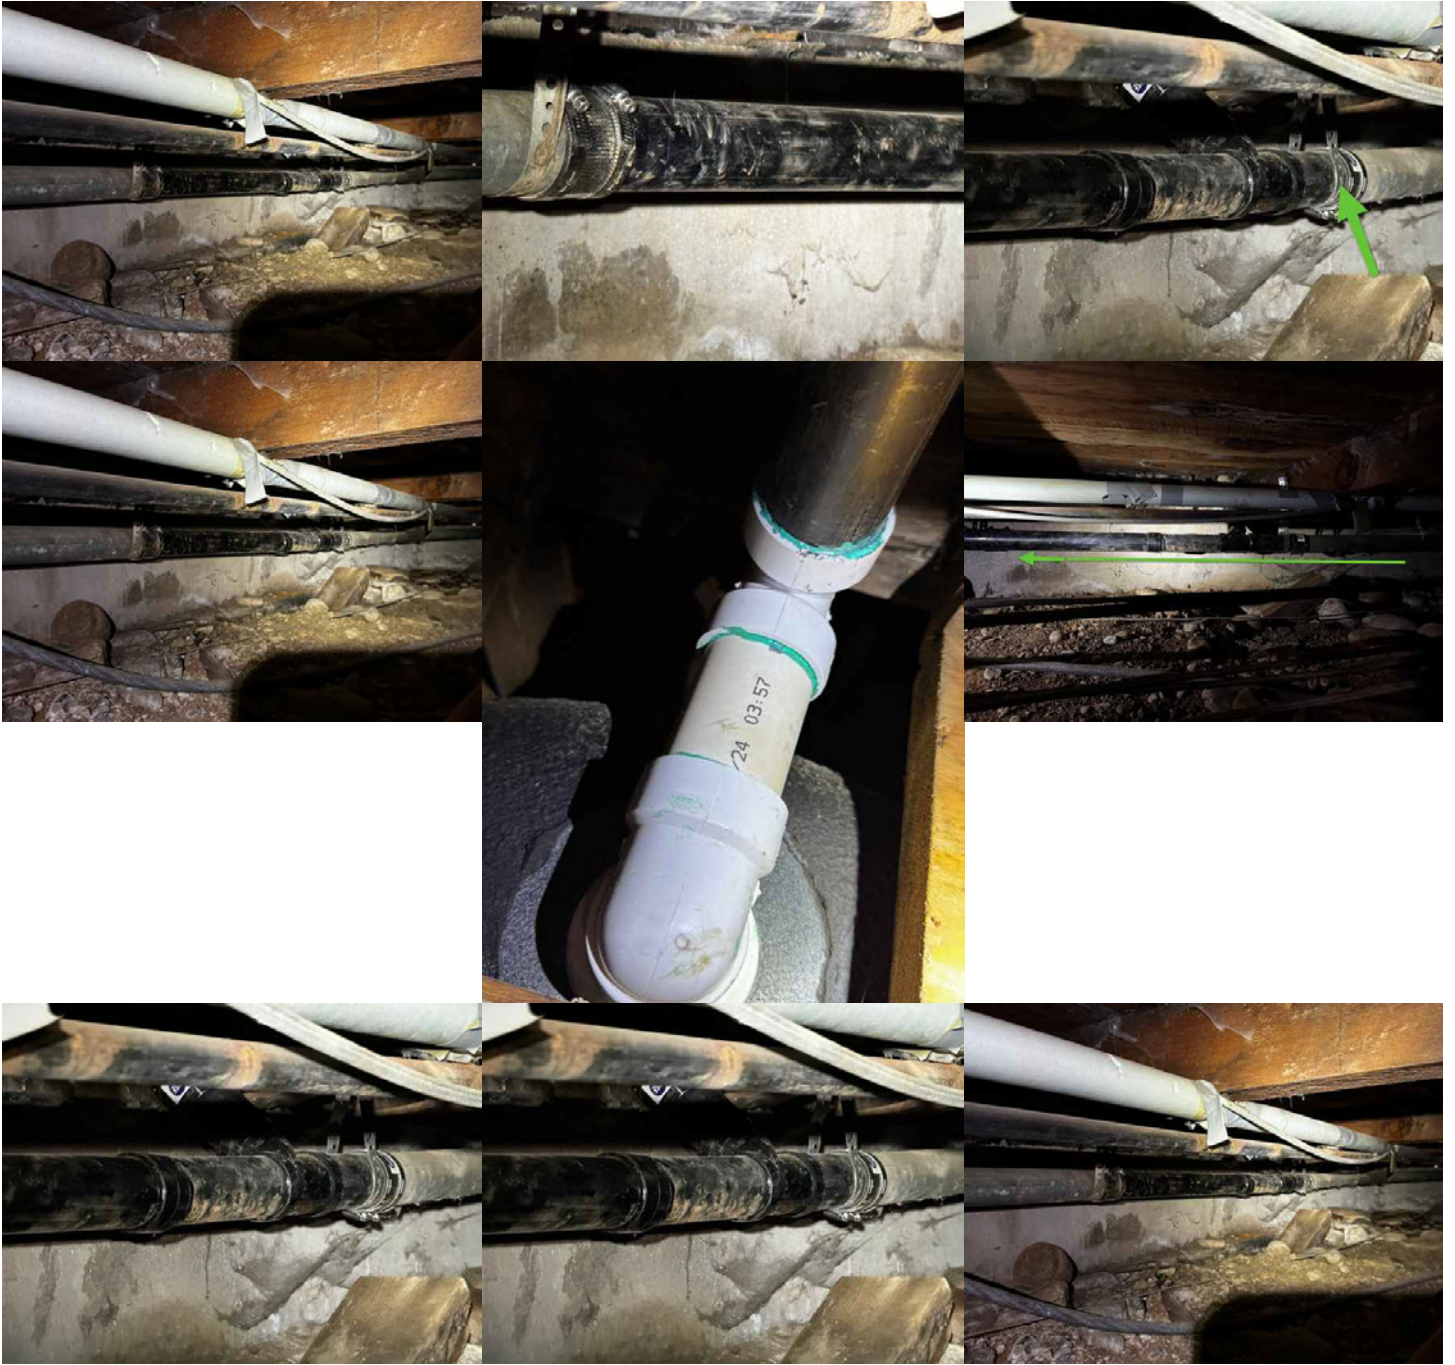
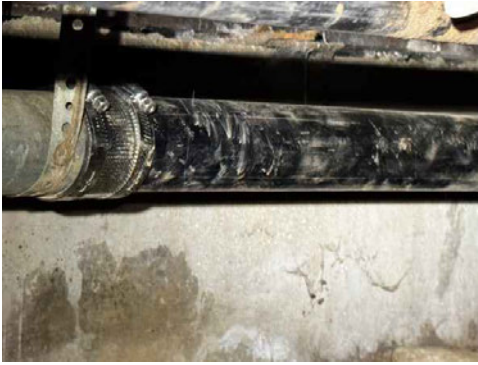
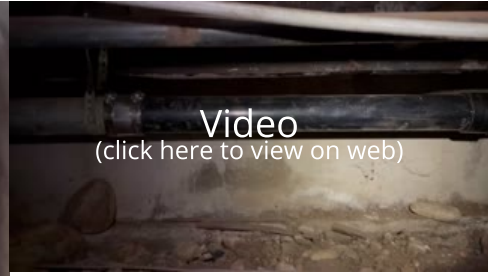
Reinspection Photos

Documentation provided indicates that ABS plumbing and a new P-trap were installed at the master shower. At the time of inspection, no ABS piping was observed beneath either shower/tub assembly, and no new P-trap installation was evident in accessible areas.

The master shower was operated at the time of inspection and no active leakage was observed.

Soil stack with water running: No master tub leaks; no ABS and P-trap replaced as shown on customer invoice
